## Burning analysis on Faston 250 series receptacle

Testing was performed on the TE Connectivity FASTON 250 SERIES RECEPTACLE to analysis the root-cause of burning issue.

This report covers the root-cause of burning issue on FASTON receptacle. Testing was performed at the Shanghai Electrical Components Test Laboratory during 09Jul2018 to 15Jul2018. The associated test number is TP-18-02035 and TP-18-02029.

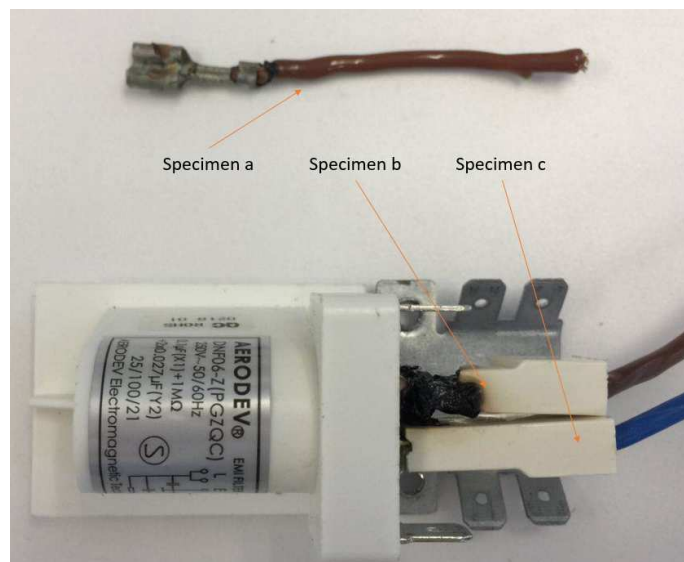
Figure 1. specimens picture

Test Group	Part No	Description	Qty.	Comments
1	280001-9	FAST 250 REC 0.3-0.8MM2 0.40X18.60 TPBR	1	Burned terminal (a)
2	280001-9	FAST 250 REC 0.3-0.8MM2 0.40X18.60 TPBR	1	Burned terminal (b)
3	280001-9	FAST 250 REC 0.3-0.8MM2 0.40X18.60 TPBR	1	Not burned terminal (c)

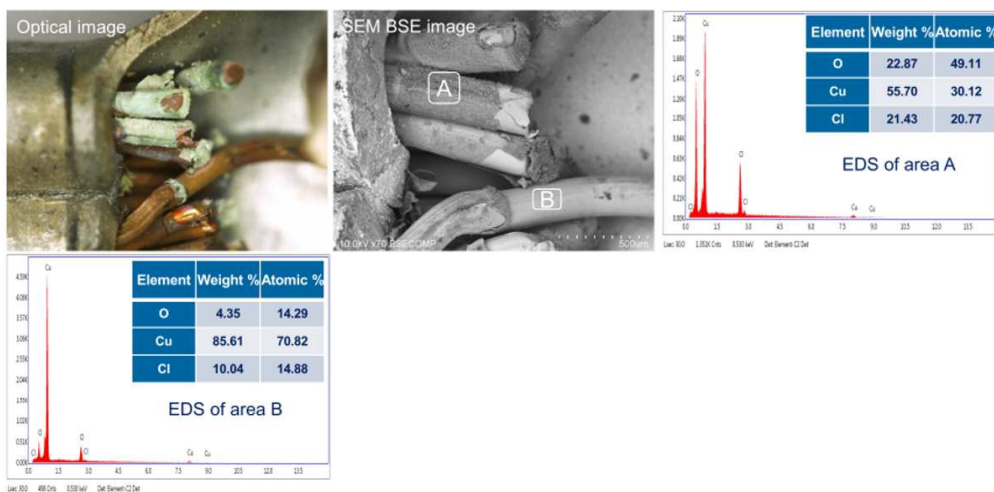
Figure 5 – Strand wire, SEM&EDS analysis result

Per SEM&EDS analysis result, the green discoloration could be caused by copper oxidation and corrosion. The green material (area A) is mainly  $CuCl_2$ .

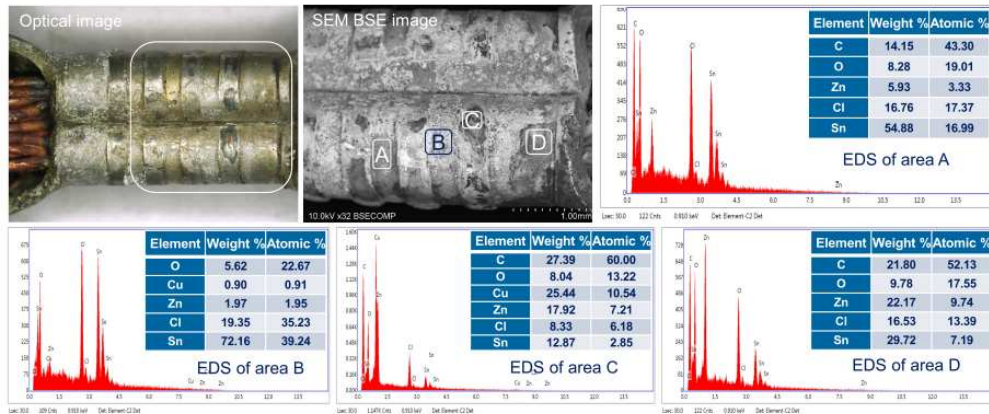
Figure 6 – Wire crimp area, SEM&EDS analysis result

Oxidation and corrosion of Cu/Zn/Sn are detected at contact wire crimp area surface, as well as some contamination (area A, area C/ D)

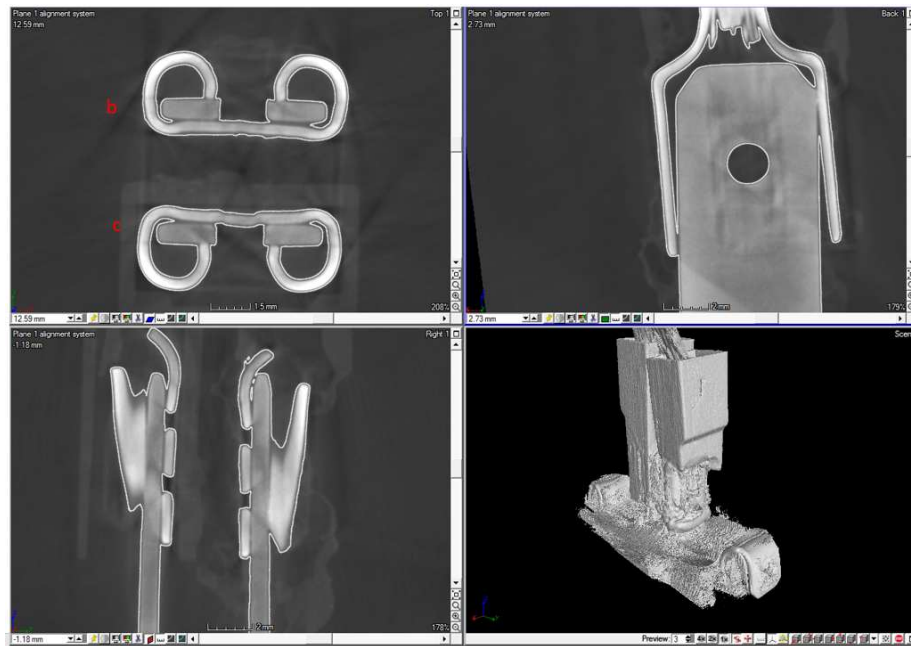
Refer to figure 7 through 8 for contact X-ray scanning summary data. Figure 7 is the data of contact area for both specimen (b) and (c), figure 8 is the data of wire crimping area for both specimen (b) and (c). according to the test result, we can found that contact area of both specimen (b) and (c) are OK, but wire crimping of specimen (b) is not good, and for crimping area of specimen (c) is OK.

Figure 7 – data of contact area for both specimen (b) and (c)

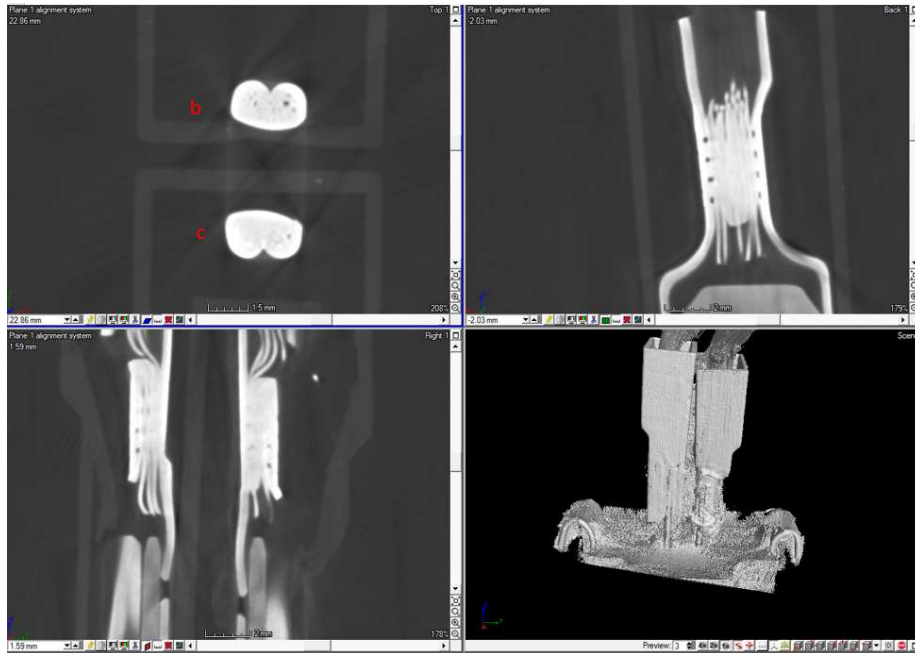
Figure 8 – data of crimping area for both specimen (b) and (c)

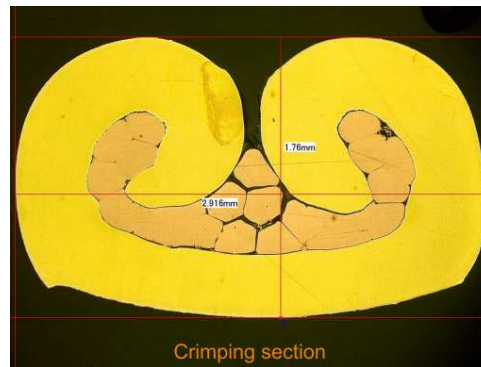
Figure 9 – cross section of specimen (a)

Refer to figure 9 through 11 for cross section summary data and table 3 – 5 for test data for crimping data. Figure 9 is the cross-section of specimen(a), figure 10 is the cross section of specimen (b), and figure 11 is the cross section of specimen (c). according to the test result, we have found that both specimen(a) and (b) are lack of strands, standard wire strands are 28, but both specimen(b) and (c) are 21 strands, CMA less than standard lead to smaller compression.

item	result	comments
Target Crimp Height :	1.7300 +/- 0.0300	
Actual Crimp Height :	1.760	CH is on the up line
Target Crimp Width :	2.8000 +/- 0.0000	
Actual Crimp Width :	2.916	
Area after crimping :	0.9436	
Crimp Compression :	0.56%	Compression low
Wire CMA:	1874	Only 21 strands, CMA less than standard leads to smaller compression.

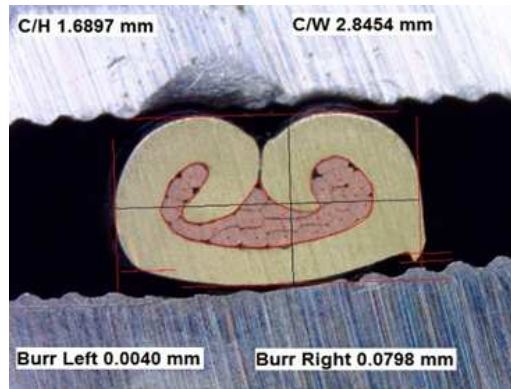
Figure 10 – cross section of specimen (b)

item	result	comments
Target Crimp Height :	1.7300 +/- 0.0300	
Actual Crimp Height :	1.6897	CH out of spec
Target Crimp Width :	2.8000 +/- 0.0000	
Actual Crimp Width :	2.8454	
Area after crimping :	0.94492	
Crimp Compression :	0.54%	Compression low
Wire CMA:	1874	Only 21 strands, CMA less than standard leads to smaller compression.

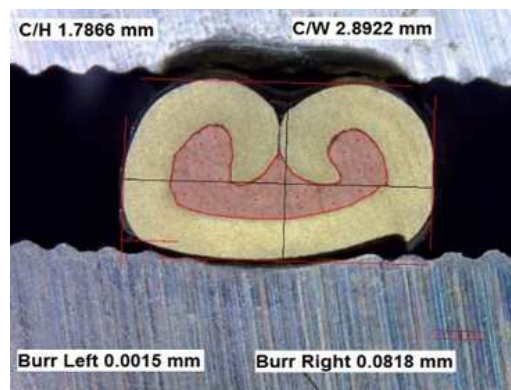
Figure 11 – cross section of specimen (c)

item	result	comments
Target Crimp Height :	1.7300 +/- 0.0300	
Actual Crimp Height :	1.7866	CH out of spec
Target Crimp Width :	2.8000 +/- 0.0000	
Actual Crimp Width :	2.8922	
Area after crimping :	1.12104	
Crimp Compression :	11.50%	
Wire CMA:	2545
