Nector S Bus Bar for North American Market

Testing was performed on the TE Connectivity Nector S Bus Bar to determine its conformance to the requirements of Design Objective 108-20294-1 Rev A.

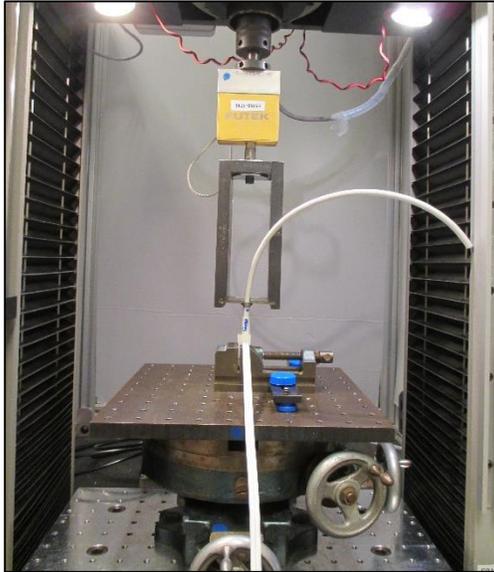
Figure 7 – Mating Force Test Setup

The Nector S Bus Bar connector socket was held in a vice on a XY table attached to the base of the tensile/compression machine. A PCB washer was placed onto the cable of the plug (Figure 8). A slotted plate was attached to a goal post fixture mounted to the load cell and moveable crosshead of the tensile/compression machine (Figure 7). The crosshead was moved downward at a rate of 0.50 inch/min until the connector was fully mated and the peak force was recorded. Test was conducted in accordance with EIA 364-13E.

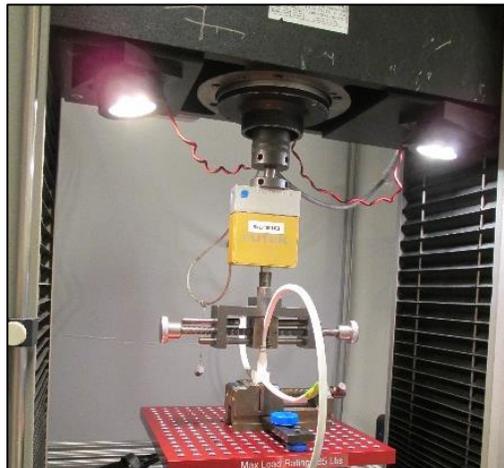
Figure 9 – Unmating Force Test Setup

The Nector S Bus Bar connector socket was held in a vice on a floating X/Y/Rotational table attached to the base of the tensile/compression machine. A clamp fixture was attached to the load cell and moveable crosshead of the tensile/compression machine (Figure 9). The clamp was firmly secured to the plug assembly. The crosshead was moved upward at a rate of 0.50 inch/min until the connector was fully unmated and the peak unmating force was recorded. Test was conducted in accordance with EIA 364-13E.
