**MULTI-BEAM XLE 270V CONNECTOR SYSTEM**

Testing was performed on the TE Connectivity\* MULTI-BEAM XLE\* 270V connector system to determine its conformance to the requirements of Design Objective 108-163023, Rev. B.

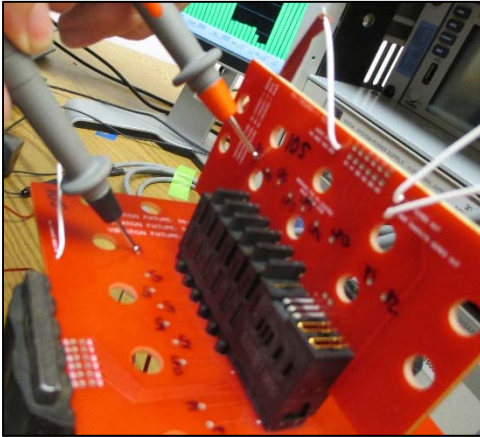
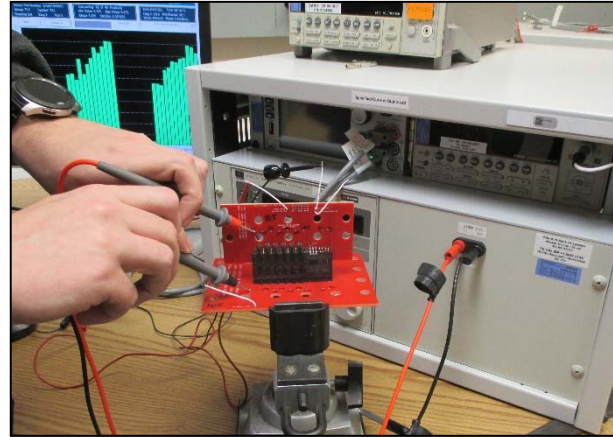
Figure 1 – Low Level Contact Resistance

Figure 2 – Low Level Contact Resistance

Low Level Contact Resistance measurements were performed in accordance with EIA 364-23C as per 108-163023, Rev. B. Measurements were made using a four-terminal configuration. Voltage measurements were manually probed with pointed probes across the contact interfaces via access connector thru holes located on the backplane and daughtercard printed circuit test boards. Current was applied through series input traces on the boards. See Figure 1 and Figure 2 for photographs of the test setup.

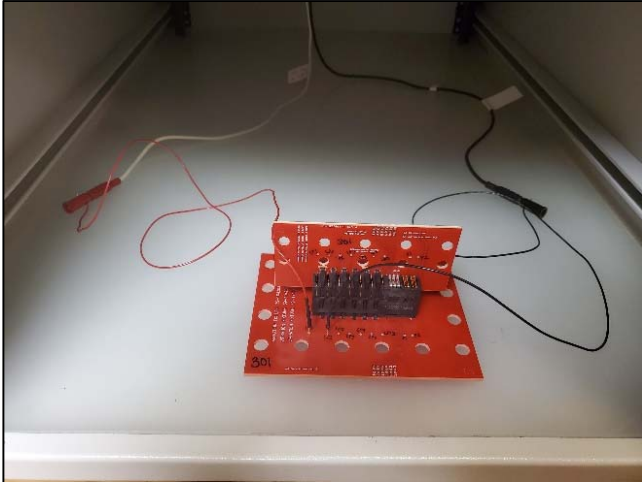
**Figure 3 – Insulation Resistance Single Connector Measurements**

Insulation Resistance measurements were performed in accordance with EIA 364-21E as per 108-163023, Rev. B. The connectors were tested in the mated condition. Insulation resistance measurements were recorded between the circuits identified in Paragraph 2.3. Wires were soldered to the access points on the printed circuit boards, and clipped to the nut of the guide post where applicable. A 500 Vdc test potential was applied between circuits for a maximum of two minutes before the insulation resistance measurement was recorded. See Figures 3 through 7 for photographs of the test setups.

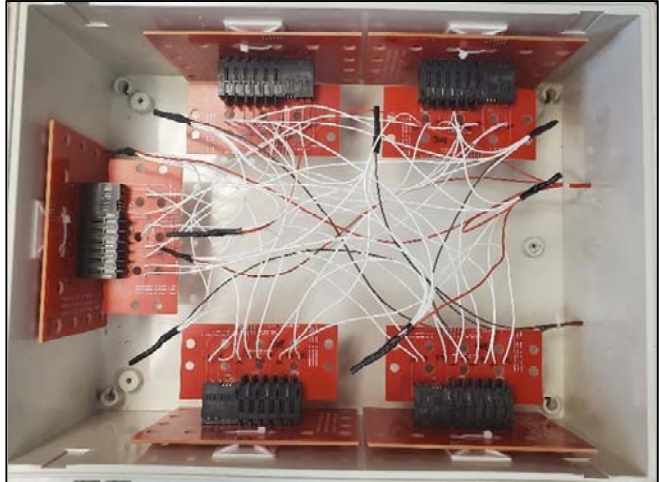
**Figure 4 – Insulation Resistance Parallel Specimen Measurements**

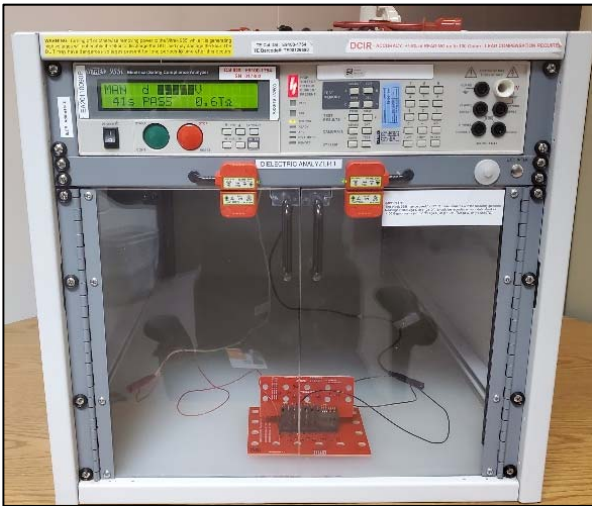
**Figure 5 – Insulation Resistance Measurements at Ambient Condition**

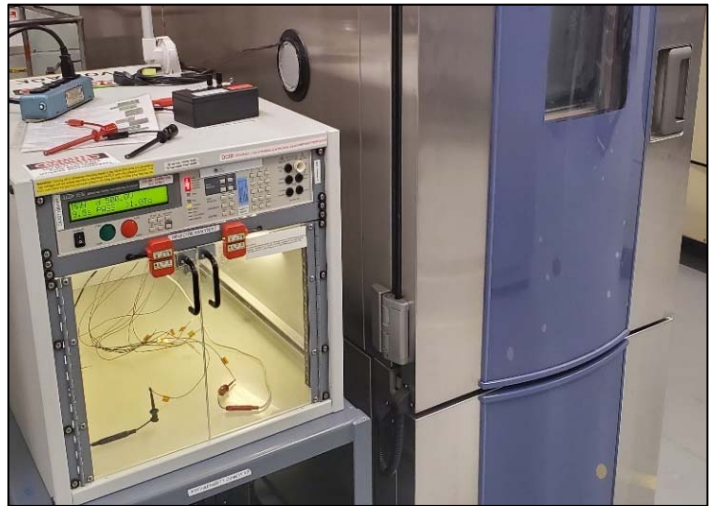
**Figure 6 – Insulation Resistance Measurements at High/Low Temperature**

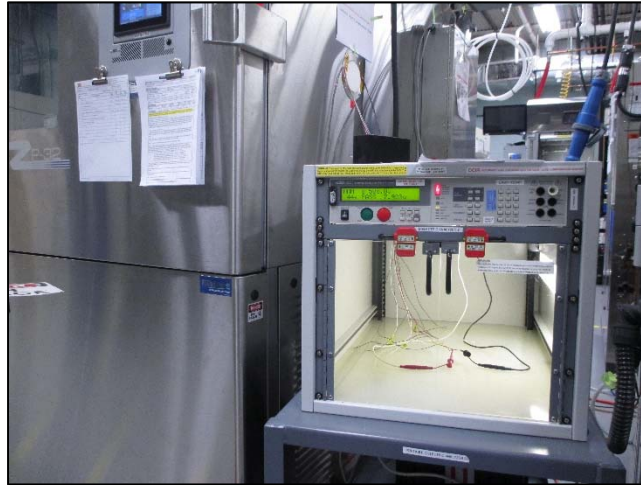
**Figure 7 – Insulation Resistance Measurements at High Humidity**

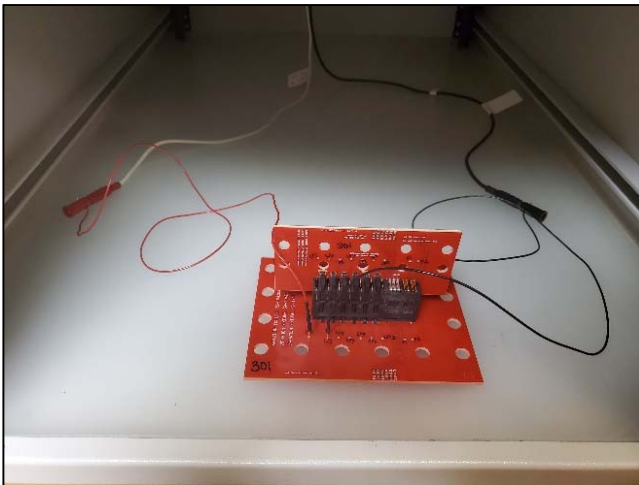
**Figure 8 – Dielectric Withstanding Voltage Single Connector Testing**

Dielectric Withstanding Voltage testing was performed in accordance with EIA 364-20F, Condition I, as per 108-163023, Rev. B. The connectors were tested in the mated condition. Testing was performed between the circuits identified in Paragraph 2.4. Wires were soldered to the access points on the printed circuit boards, and clipped to the nut of the guide post where applicable. The specified test potential was applied between circuits at a rate of 500 volts per second, and maintained for a period of 60 seconds. See Figures 8 through 12 for photographs of the test setups.

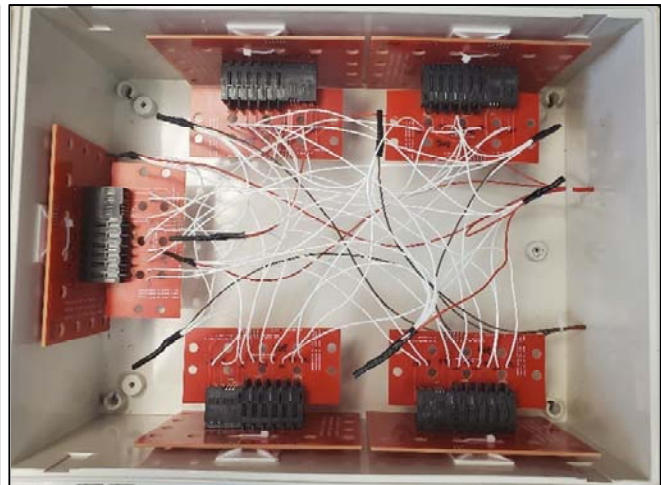
**Figure 9 – Dielectric Withstanding Voltage Parallel Specimen Testing**

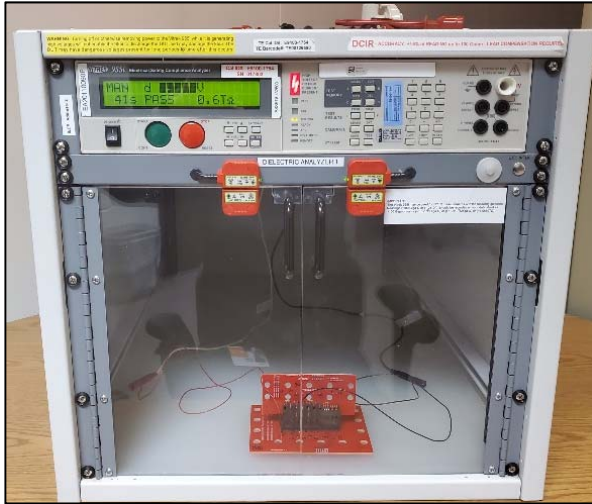
**Figure 10 – Dielectric Withstanding Voltage Testing at Ambient Condition**

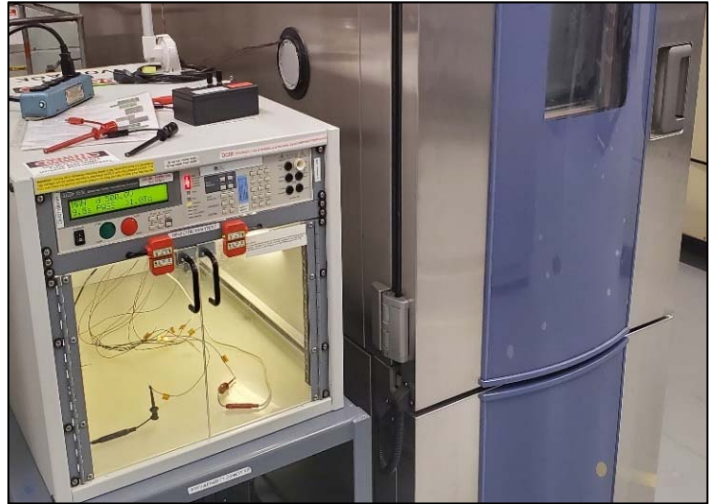
**Figure 11 – Dielectric Withstanding Voltage Testing at High/Low Temperature**

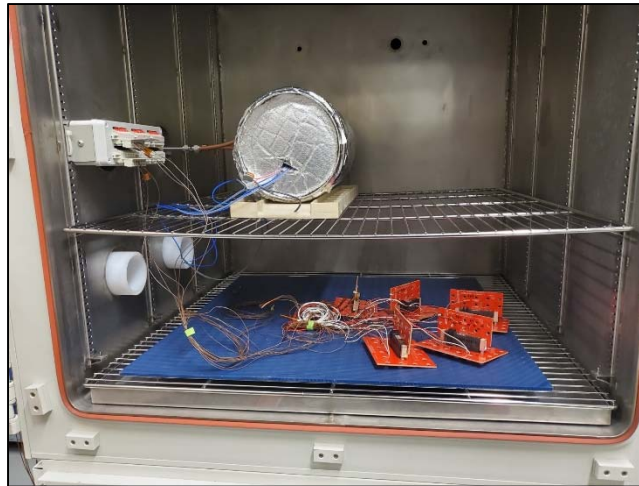
**Figure 12 – Dielectric Withstanding Voltage Testing at Simulated Altitude**

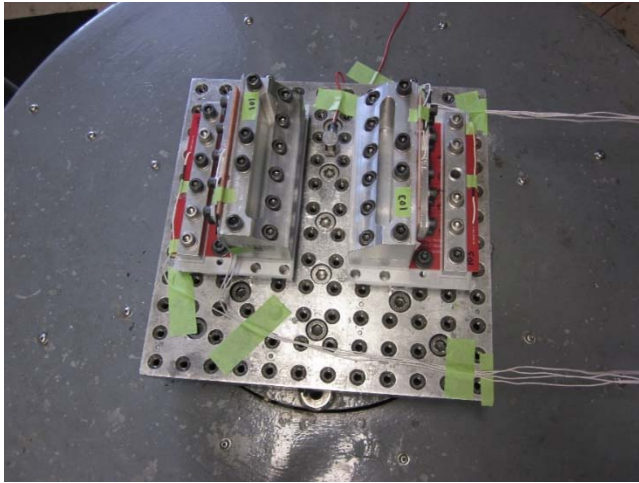
**Figure 13 – Vibration  
Vertical Axis**

Vibration testing was performed in accordance with VITA 47.1-2019, Section 4.4.3 (Vibration Class V3) and MIL-STD-810H, Method 514.8, Procedure I, as per 108-163023, Rev. B. The parameters of this test condition are specified by a random vibration spectrum with excitation frequency bounds of 50 and 2000 Hertz (Hz). The power spectral density (PSD) at 5 Hz is 0.005 G<sup>2</sup>/Hz. The spectrum slopes up at 3 dB per octave to a PSD of 0.10 G<sup>2</sup>/Hz at 100 Hz. The spectrum is flat at 0.10 G<sup>2</sup>/Hz from 100 Hz to the frequency of 1000 Hz. The spectrum slopes down at 3 dB per octave from 1000 Hz to a 2000 Hz. The root-mean square amplitude of the excitation was 12.82 GRMS. The test specimens were subjected to this test for 1 hour in each of the three mutually perpendicular axes, for a total test time of 3 hours per test specimen. The test specimens were monitored for discontinuities of 1 microsecond or greater using an energizing current of 100 milliamperes. See Figures 13 through 15 for photographs of the test setup.

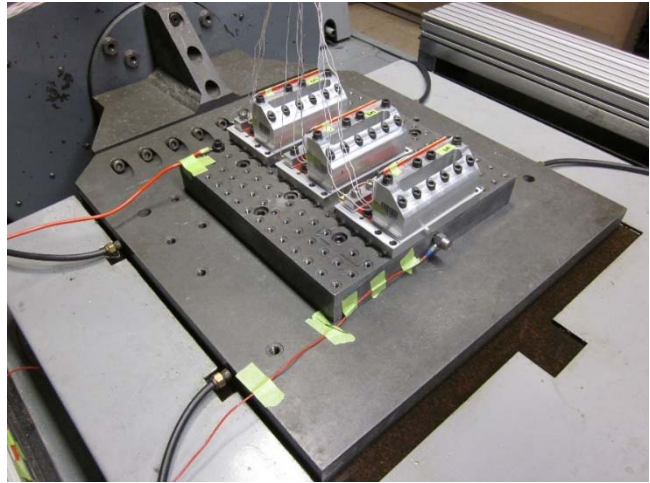
**Figure 14 – Vibration  
Lateral Axis**

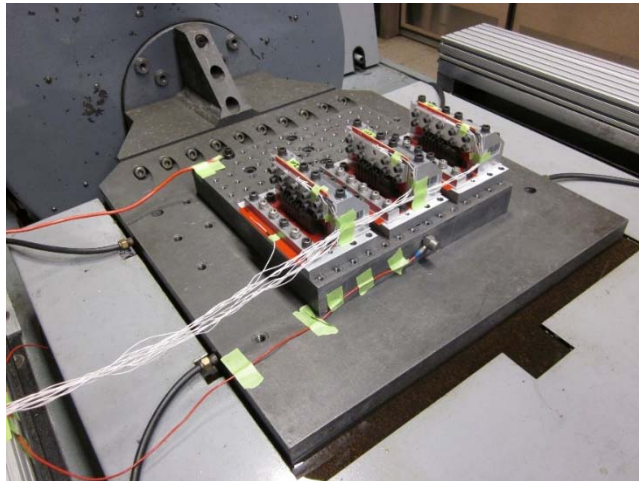
**Figure 15 – Vibration  
Longitudinal Axis**

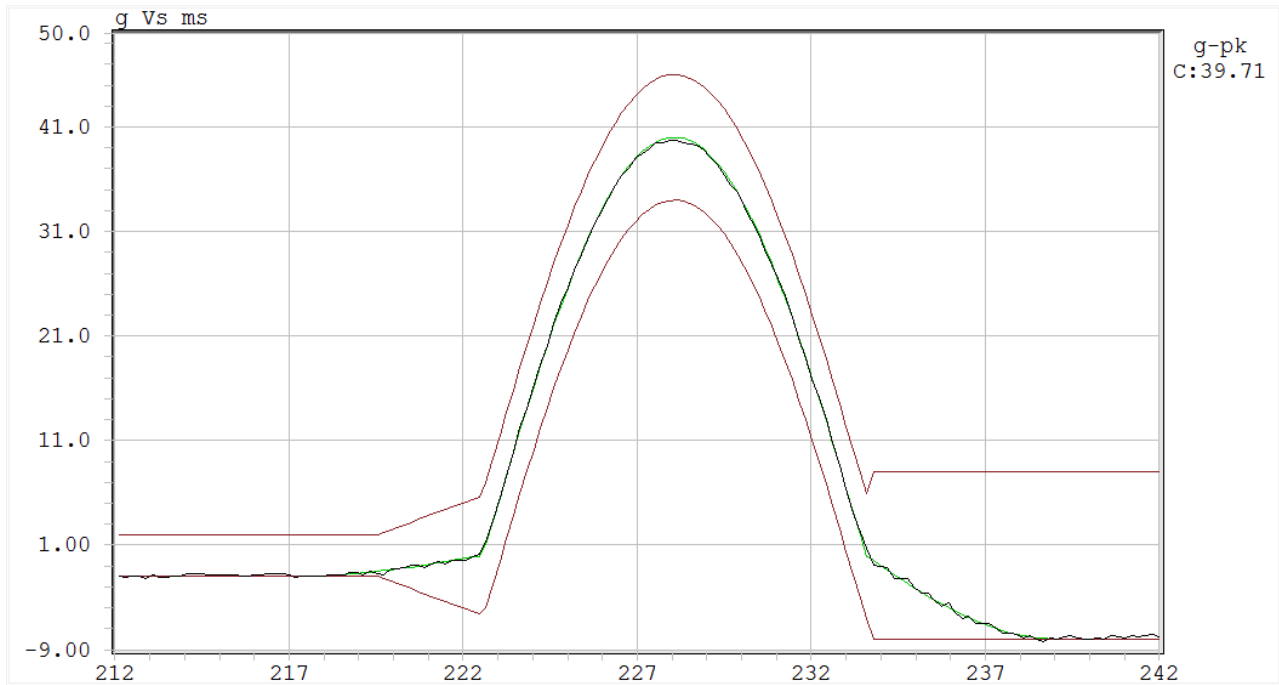
**Figure 16 – Shock Pulse Profile**

Shock testing was performed in accordance with VITA 47.1-2019, Section 4.5.2 (Operating Shock Class OS2) and MIL-STD-810H, Method 516.8, Procedure I, as per 108-163023, Rev. B. The parameters of this test condition are a half-sine waveform with an acceleration amplitude of 40 gravity units (g's peak) and a duration of 11 milliseconds (see Figure 16). Three shocks in each direction were applied along the three mutually perpendicular axes of the test specimens, for a total of eighteen shocks. The test specimens were monitored for discontinuities of 1 microsecond or greater using an energizing current of 100 milliamperes. See Figure 17 and Figure 18 for photographs of the test setup.

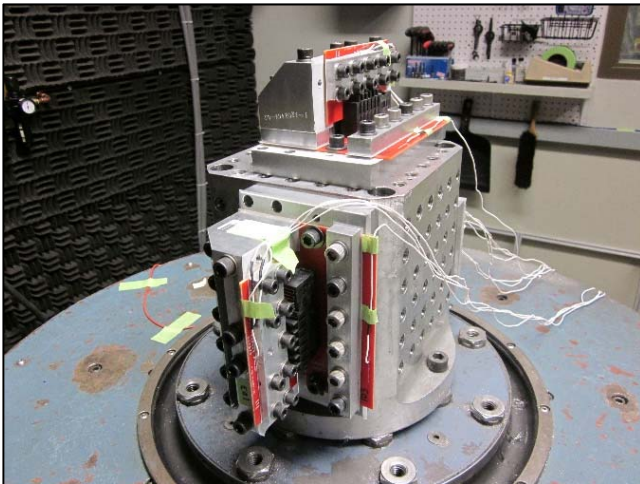
**Figure 17 – Shock Vertical and Longitudinal Axes**

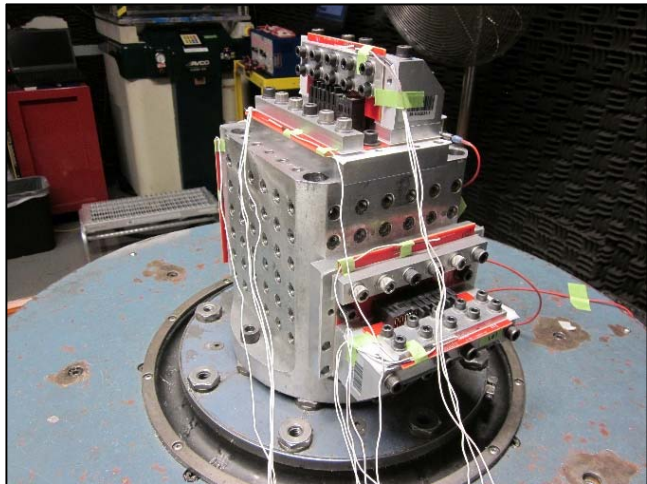
**Figure 18 – Shock Vertical and Lateral Axes**

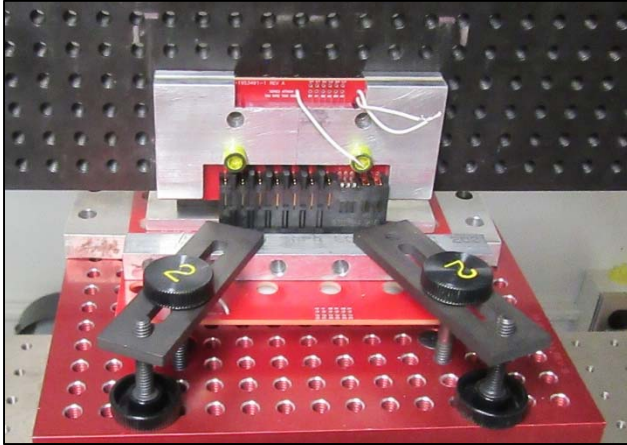
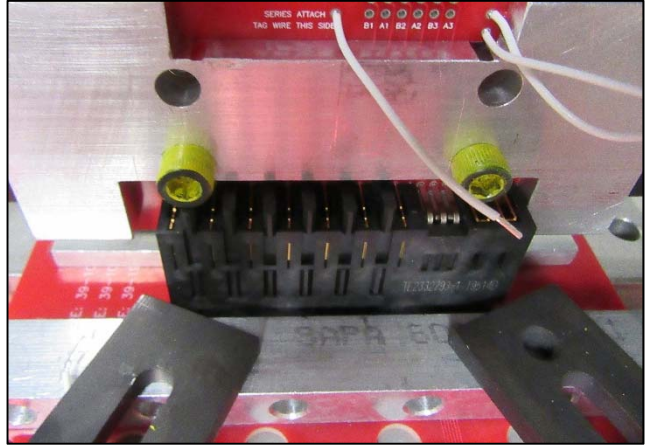
Figure 19 – Durability Test Setup

Figure 20 – Durability Test Setup

Durability testing was performed in accordance with VITA 47.1-2019, Section 4.1.4 as per 108-163023, Rev. B. The daughter card connector was mounted to a right angle plate secured to the top of an automated durability test system. The corresponding backplane connector was secured to an floating X-Y-R table mounted to the base of the durability test system. Each connector was fully mated and unmated for 250 cycles at a rate of 500 cycles per hour. See Figure 19 and Figure 20 for photographs of the test setup.

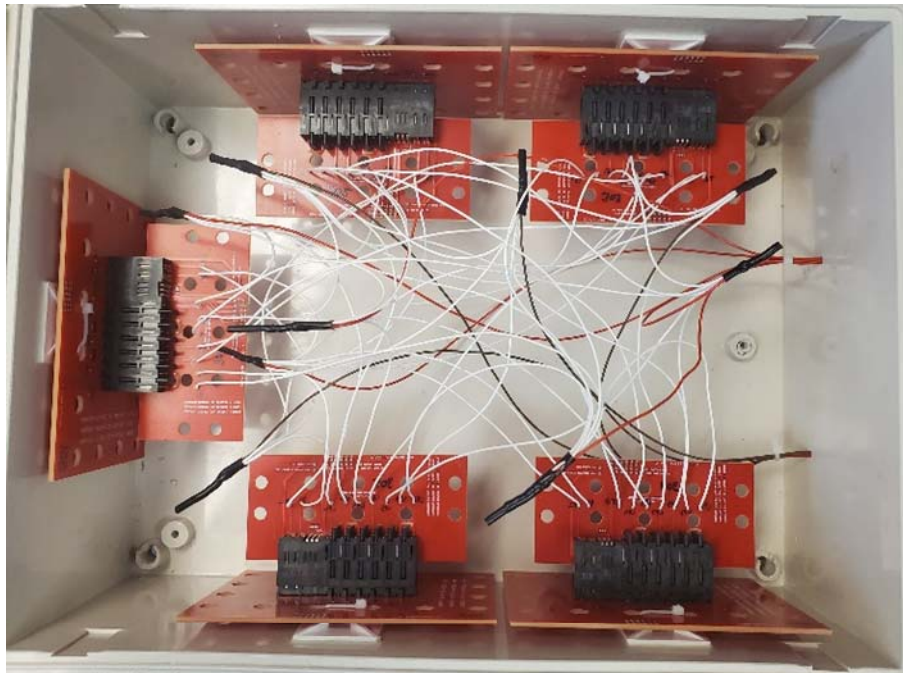
Figure 21 – Specimens Secured in Simulated Plug-In Unit Enclosure (Shown Without Enclosure Lid)

Humidity testing was performed in accordance with VITA 47.3-2019, Section 4.7 and MIL-STD-810H, Method 507.6, Procedure II, as per 108-163023, Rev. B. The mated specimens were first preconditioned for 24 hours at a temperature of 23 ±2 °C and 50 ±5 percent RH prior to starting the humidity test. The mated specimens were then placed inside a simulated plug-in unit enclosure with drain holes (see Figure 21) and subjected to 10 humidity-temperature cycles. Each cycle consisted of a 24-hour cycle ranging from 30 to 60 °C with humidity of 95 ±4 percent as indicated in Figure 22. At the end of cycle 5 and cycle 10, Insulation Resistance measurements were recorded while the specimens were in the humidity chamber at high humidity conditions. Upon completion of the exposure, the Insulation Resistance was again measured following a 24-hour ambient conditioning period.

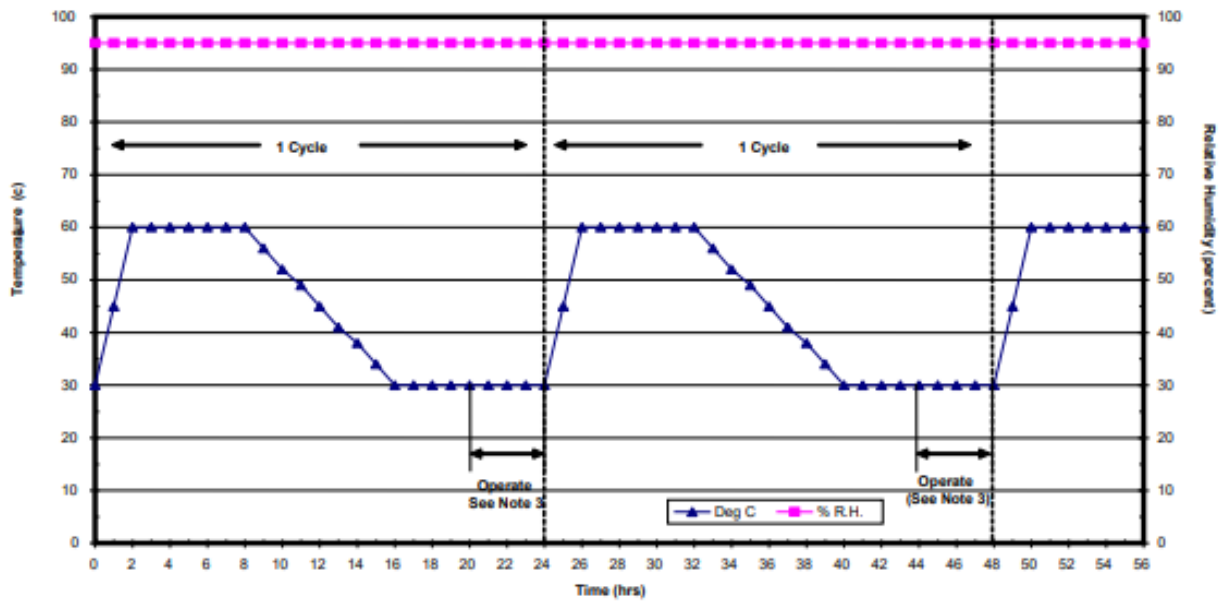
Figure 22 – Aggravated Temperature-Humidity Cycle (from MIL-STD-810H Figure 507.6-7)

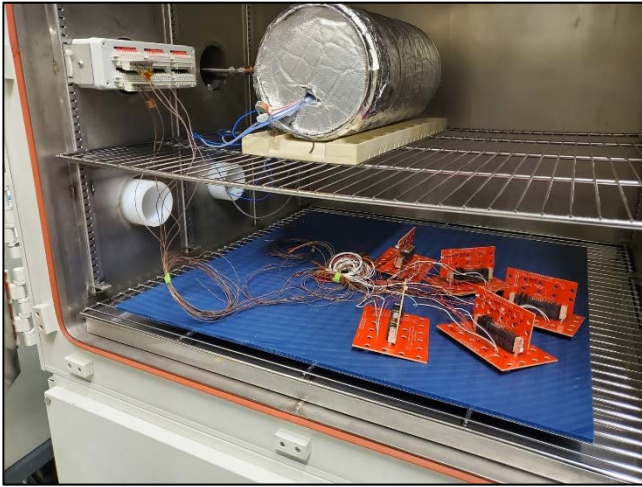
Figure 23 – Altitude Chamber Test Setup

Altitude testing was performed in accordance with VITA 47.1-2019, Section 4.8, with the exception that the altitude was specified at 70,000 feet, and MIL-STD-810H, Methods 500.6, Procedure II, as per 108-163023, Rev. B. The mated specimens were wired in parallel to facilitate electrical testing of all specimens simultaneously and placed inside the altitude chamber. The pressure inside the chamber was then reduced to a simulated altitude of 70,000 feet. Following a 2-minute stabilization at altitude, the specified test potential was applied between circuits at a rate of 500 volts per second, and maintained for a period of 60 seconds. See Figure 23 and Figure 24 for photographs of the test setup.

Rapid Decompression testing was performed in accordance with VITA 47.1-2019, Section 4.9, with the exception that the decompression was specified at take place from 8,000 feet to 70,000 feet in up to 4 minutes, and MIL-STD-810H, Methods 500.6, Procedure III, as per 108-163023, Rev. B. The mated specimens were wired in parallel to facilitate electrical testing of all specimens simultaneously and placed inside the altitude chamber. The pressure inside the chamber was then reduced to a simulated altitude of 8,000 feet. Following stabilization at 8,000 feet altitude, the specified test potential was applied between circuits at a rate of 500 volts per second. The pressure inside the chamber was then further reduced to a simulated altitude of 70,000 feet in approximately 2 minutes. The specified test potential was maintained through the decompression to high altitude, and for an additional 10 minutes following stabilization at 70,000 feet. See Figure 23 and Figure 24 for photographs of the test setup.

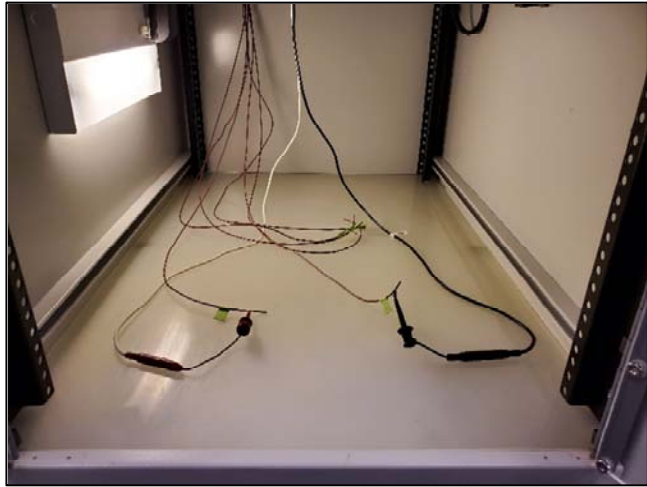
Figure 24 – Dielectric Analyzer Test Setup

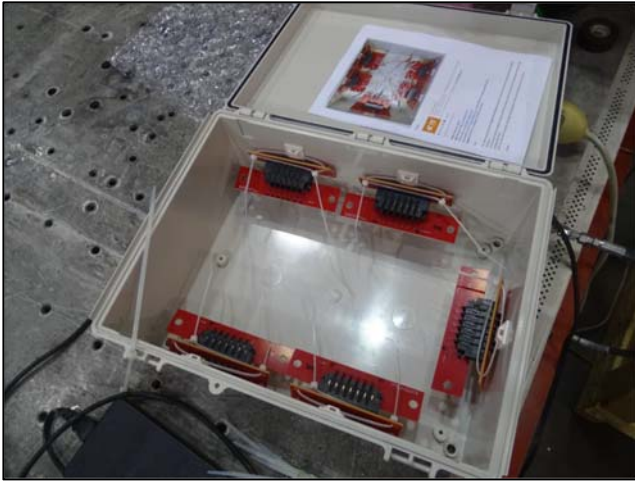
**Figure 25 – Specimens Secured In Simulated Plug-In Unit Enclosure**

Corrosion Resistance testing was performed in accordance with VITA 47.1-2019, Section 4.6.2 and MIL-STD-810H, Method 509.7, as per 108-163023, Rev. B. The mated specimens were placed inside a simulated plug-in unit enclosure with drain holes (see Figure 25) and subjected to 500 hours of a salt fog exposure. Upon completion of the exposure, the enclosure was placed on a cart in the salt fog room to dry with no rinsing. The chamber operating parameters were as follows:

The Procedure I Blowing Dust testing was performed by first placing the specimens inside a simulated plug-in unit enclosure with drain holes (see Figure 25), then placing the enclosure, mounted vertically on a test frame (see Figure 26), inside the dust chamber with the front of the enclosure facing the airflow (see Figure 27). The chamber temperature was set to 23°C and allowed to stabilize. A GN<sub>2</sub> purge was fed into the chamber to maintain the humidity level below 30%. The air speed was adjusted to 8.9 meters per second, and the dust feed adjusted to deliver 10.6 grams per cubic meter of chamber volume. The enclosure was exposed to the blowing dust in this orientation for 3 hours. Upon completion of the first 3-hour exposure, the enclosure was rotated 180° with the back now facing the airflow (see Figure 28) and exposed to a second 3 hours at the conditions noted above, for a total exposure time of 6 hours.

The Procedure II Blowing Sand testing was performed by first placing the specimens inside a simulated plug-in unit enclosure with drain holes (see Figure 25), then placing the enclosure, mounted vertically on a test frame (see Figure 26), inside the sand chamber with the front of the enclosure facing the airflow (see Figure 29). The chamber temperature was set to 85°C and allowed to stabilize. The air speed was adjusted to 18.8 meters per second, and the sand feed adjusted to deliver 2.2 grams per cubic meter of chamber volume. The enclosure was exposed to the blowing sand in this orientation for 1.5 hours. Upon completion of the first 1.5-hour exposure, the enclosure was rotated 180° with the back now facing the airflow (see Figure 30) and exposed to a second 1.5 hours at the conditions noted above, for a total exposure time of 3 hours.

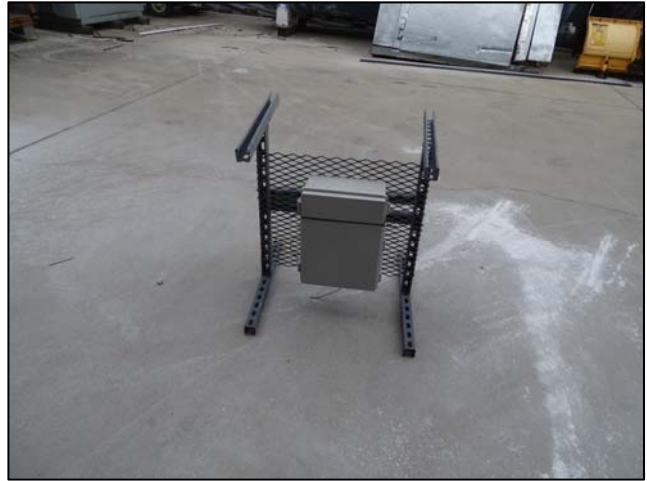
**Figure 26 – Simulated Plug-In Unit Enclosure Secured to Test Frame**

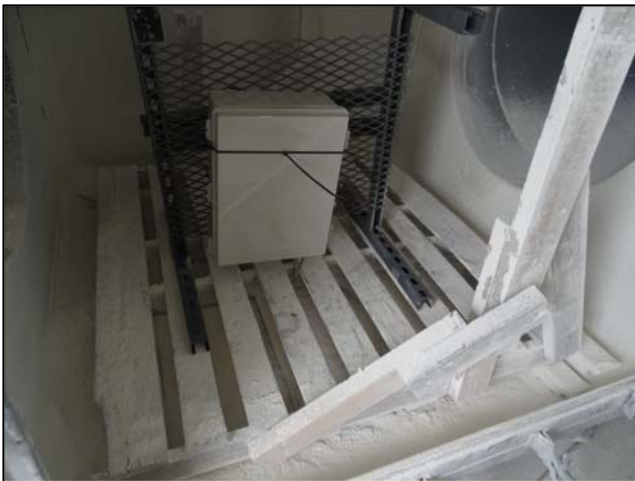
**Figure 27 – Enclosure In Dust Chamber Orientation 1**

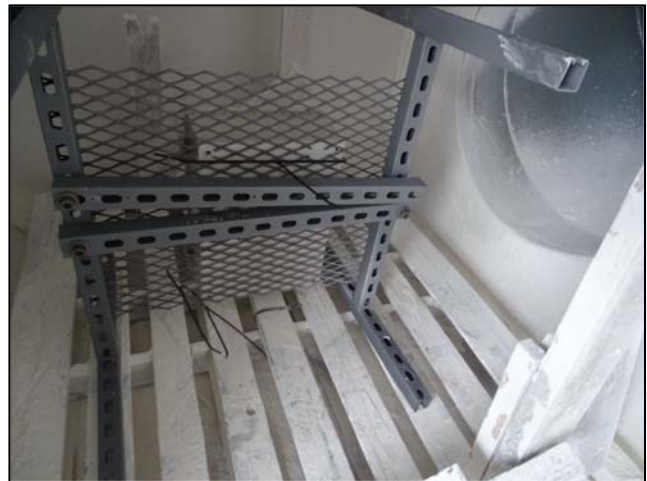
**Figure 28 – Enclosure in Dust Chamber Orientation 2**

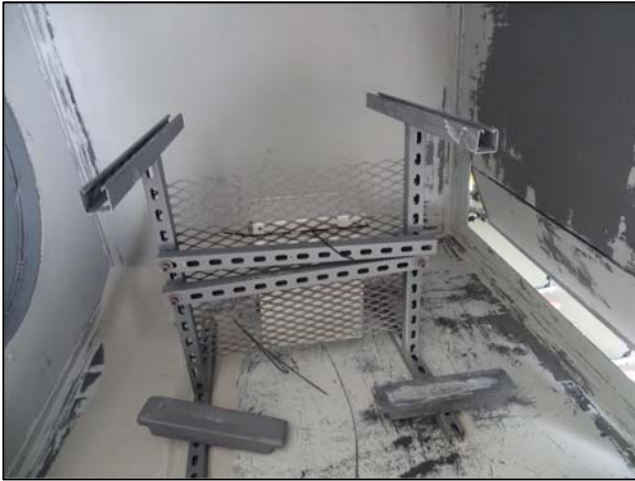
**Figure 29 – Enclosure In Sand Chamber Orientation 1**

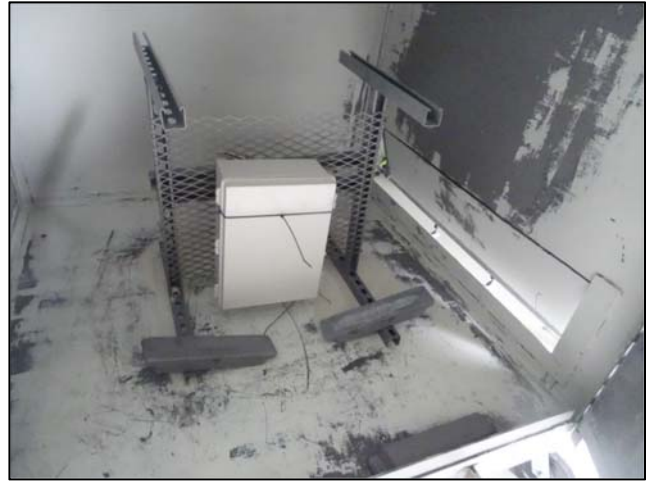
**Figure 30 – Enclosure in Sand Chamber Orientation 2**

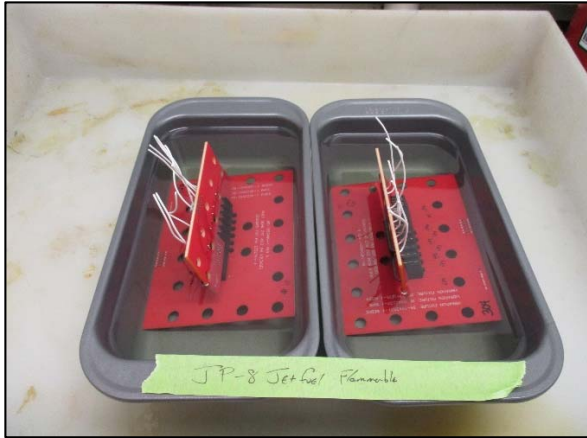
Figure 31 – Fluid Contamination Immersion

The specimens were placed into a container filled with jet fuel (JP-8) until the specimens were fully immersed. After 8 hours of exposure, the specimens were removed from the jet fuel and allowed to drain/dry for 16 hours. The specimens were then immersed in isopropyl alcohol (TT-I-735) by for 5 minutes, and then allowed to dry for 8 hours. The specimens were next placed into a container filled with electronic coolant (MIL-PRF-87252) until the specimens were fully immersed. After 8 hours of exposure, the specimens were removed from the coolant and allowed to drain/dry for 16 hours. Visual inspection was done after drying. The specimens were then immersed in isopropyl alcohol (TT-I-735) by for 5 minutes, and then allowed to dry for 8 hours. A visual inspection of the specimens was performed following each drying cycle. See Figure 31 and Figure 32 for photographs of the test setup.

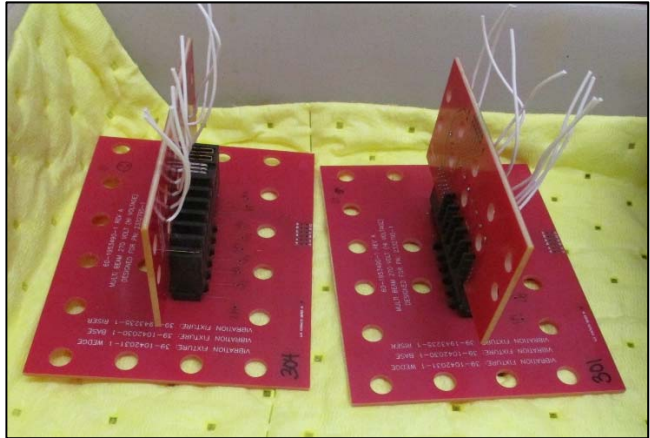
Figure 32 – Fluid Contamination Drying
