# **Qualification of Low-Force Mezalok\* 114 Position Socket** Connector

Testing was performed on the TE Connectivity\* Low-Force Mezalok 114 position (114 p) sockets to determine their conformance to selected requirements of Design Objective 108-160206, Rev. A.

This report covers the electrical, mechanical, and environmental performance of the Low-Force Mezalok 114 p sockets in 10mm & 18mm stack heights. Testing was performed at the Harrisburg Electrical Components Test Laboratory between 10/12/2020 and 3/1/2021. Documentation is on file and maintained at HECTL under test number EA20200400T.

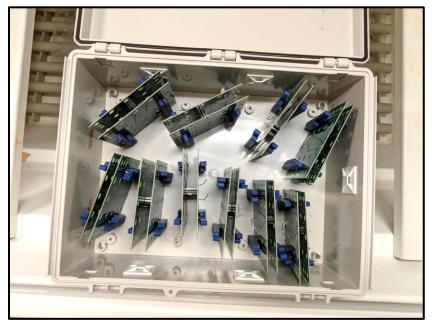
Figure 19– Test specimen in salt spray enclosure

Per TE Connectivity Specification 108-160206. Rev. A test method, a specimen enclosure containing the specimens was placed in the chamber on horizontal racks by the test requestor. The enclosure had four 3/8" drain holes in the bottom (one in each corner). See Figure 19 & Figure 20 for views of the salt spray setup. The chamber was operated for a total of 48 hrs. See Table 3 for chamber collection data.

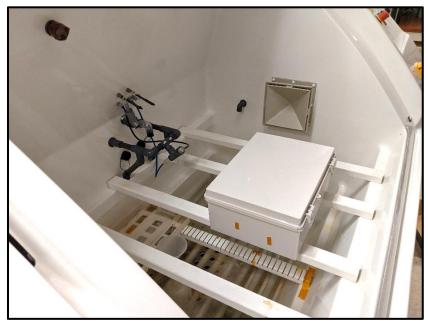
Figure 20 – Salt spray enclosure inside salt chamber

- Chamber Temperature: 35°C.
- Aeration Tower temperature: 48°C.
- 5% Brine Solution Purity: Sodium Chloride with no more than .3% impurities.
- Aeration Tower Pressure: 22 PSI.
- Brine Solution pH Range: 6.5 to 7.2.
- Specific Gravity Range: 1.031 to 1.038.
- Collection rate: .5 to 3ml per hour.
