Workmanship Specification

Ultrasonic Welding, LC & SC Adapters

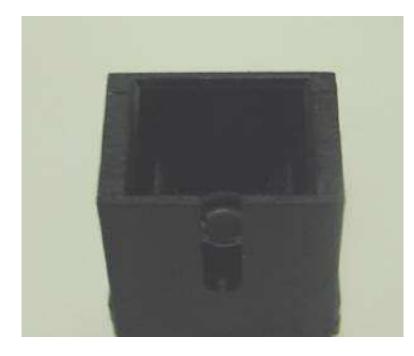
ACCEPTABLE

Tool Marks SC Figure 2

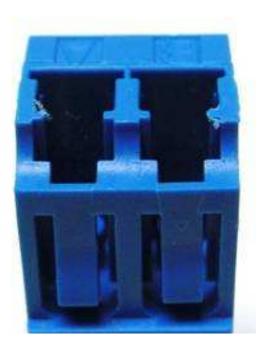
NOT ACCEPTABLE

Heavy Tool Marks and Flash LC, LC Cutout Figure 6

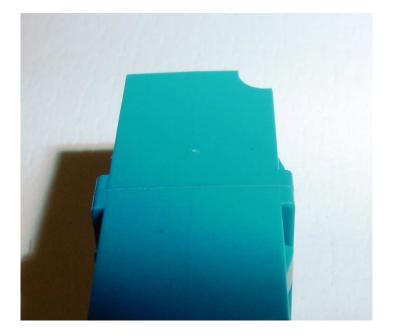
ACCEPTABLE

Flash Around the Weld Line LC, LC Cutout Figure 9

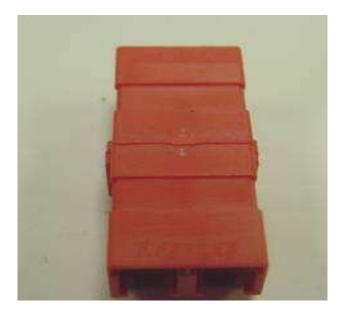
NOT ACCEPTABLE Heavy Flash Around the Weld Line LC Secure Figure 10

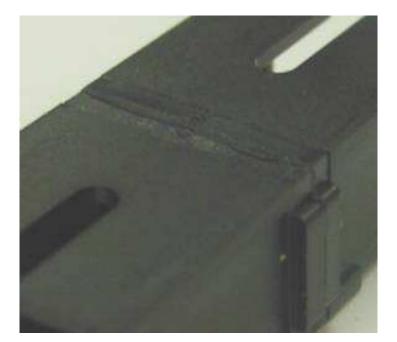
NOT ACCEPTABLE Heavy Flash Around the Weld Line SC Figure 11

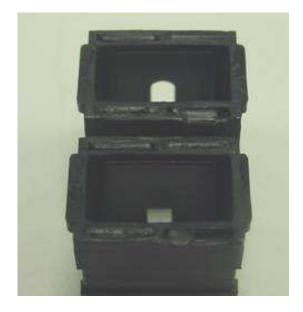
ACCEPTABLE

Weld at Break Test, SC Figure 14

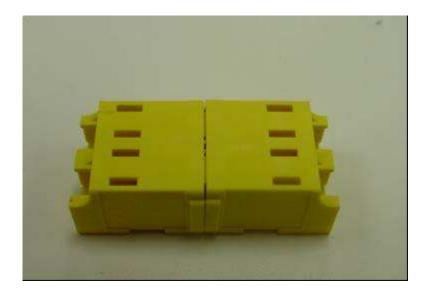
NOT ACCEPTABLE

Gap Between Housings LC Secure Figure 18

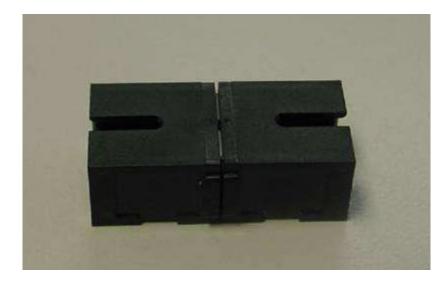
NOT ACCEPTABLE Gap Between Housings SC Figure 19

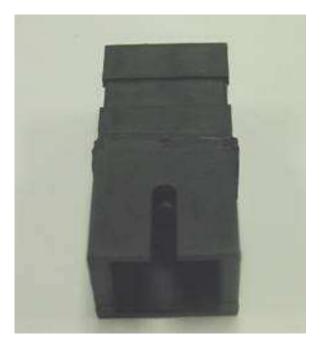
Housings Reversed Figure 21

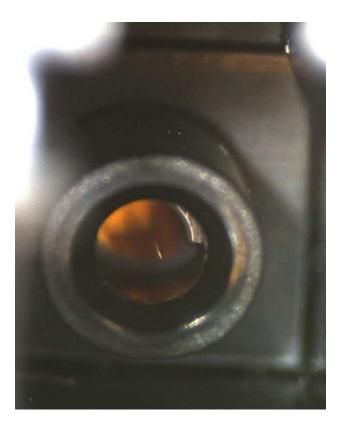
Broken Sleeve Figure 31
