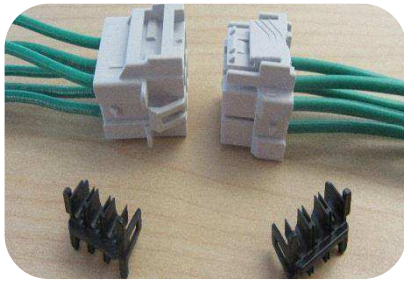
1. Remove the TPA from the back of the housing and discard it.

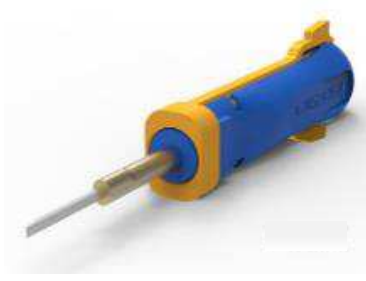
2. Remove all contacts from the housing using PTL extraction tool 1452426-1 (shown with bevel edge to the rear). Follow step 3.

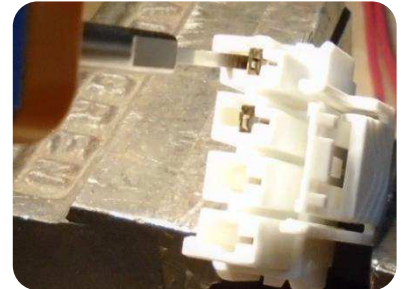
3. Align the tool tip (bevel edge toward the bottom of the connector) with the housing circuit cavity, and insert it under the contact. Push down on the latch while gently pulling the wire until the contact is free.

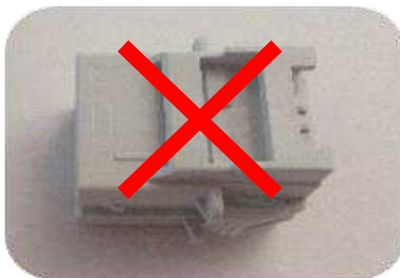
3. Discard the housing as it may have internal damage. It is important that the housing **not** be re-used because internal damage cannot always be easily determined.

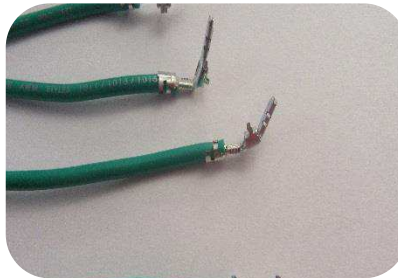
5. Inspect all contacts for straightness and damage. Confirm compliance with [114-106118](#) for PTL wire-to-wire contacts or [114-106147](#) for PTL MFBL contacts. Do not attempt to straighten bent or distorted contacts. If any contact does not comply or is questionable, cut it from the wire directly behind the stabilizer, re-strip the wire, and crimp with a new contact. The new contact must have the same part number as the one removed. Refer to the 114-document for crimp requirements.

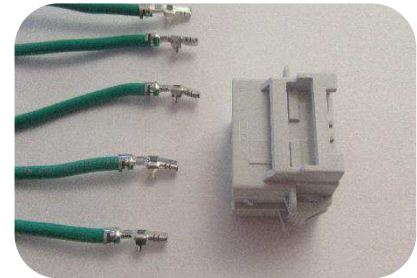
6. Insert all contacts into a new housing. There will be a slight audible click when the contact latches onto the housing.

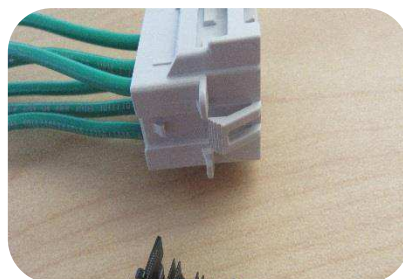
7. Give a slight tug to all wires to ensure that the contacts are latched onto the housing.

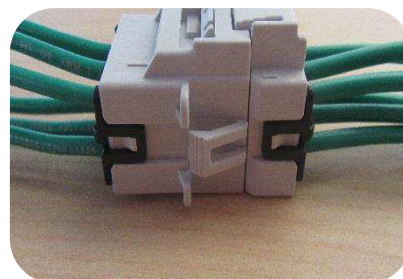
8. Install a new TPA. Mate the housing and test.
