SRC - Sealed Rectangular Connector

Product qualification testing of SRC connector system as per TEC-108-160018.

This report covers the electrical and environmental performance of the Sealed Rectangular Connector (SRC) system.

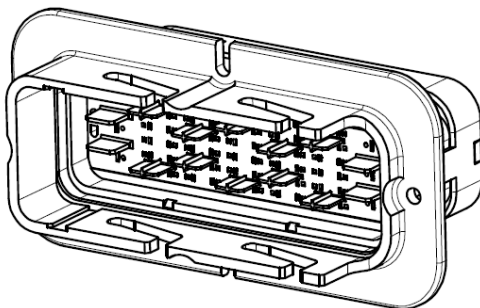
Figure 1: SRC 60+6 Mixed Power Blade Assembly Housing Mating Interface

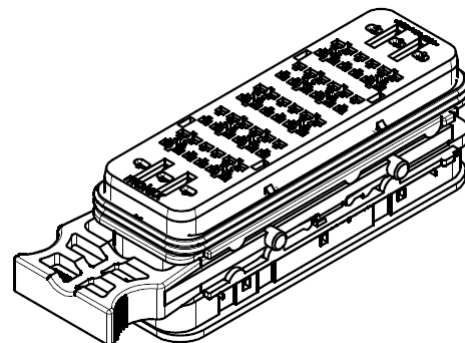
Figure 2: SRC 60+6 Mixed Power Female Receptacle Assembly Housing Mating Interface

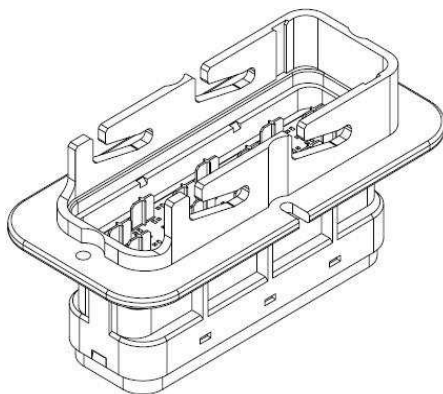
Figure 3: SRC 84 Pin Mixed Power Female Receptacle Housing Mating Interface

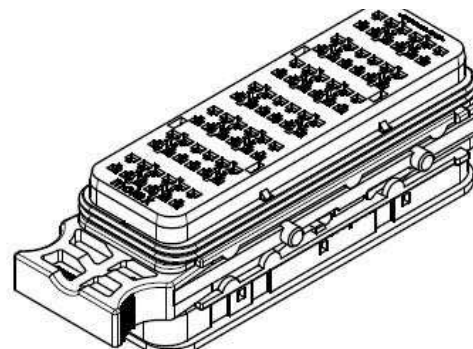
Figure 4: SRC Female 84 Pin Receptacle Housing Assembly

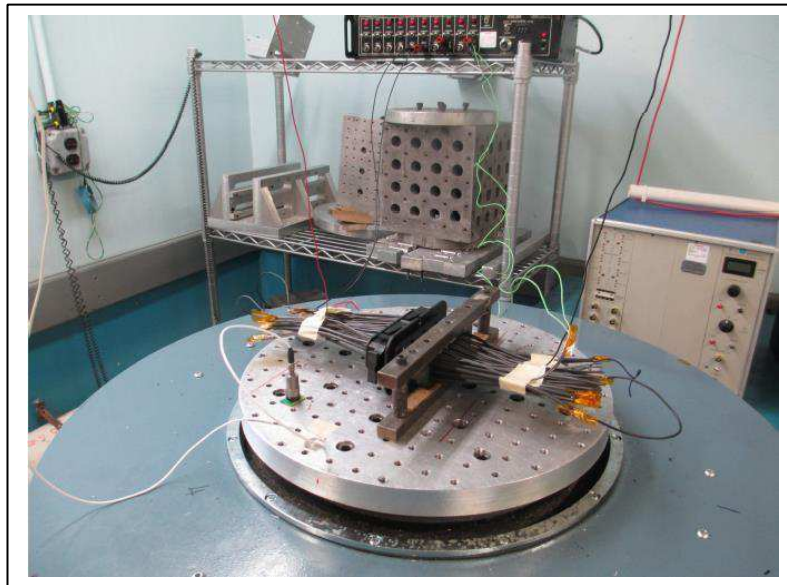
Figure 7: Test Group B : Contech Research Inc.: Mechanical Shock/Vibration Typical Test Setup

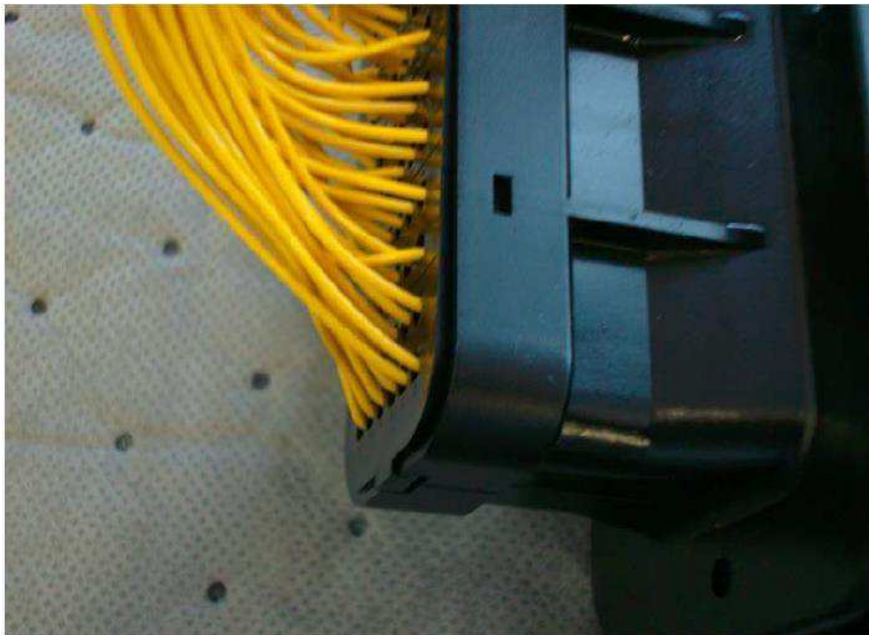
Figure 9: Observation that lifting of the edge of the rear cover feature from the female housing part occurred. This was due to diesel impregnating the seal

* The following observation was noted that during the Fluid Immersion Test for diesel that lifting of the edge of the rear cover feature from the female housing occurred. This was due to diesel impregnating the seal.

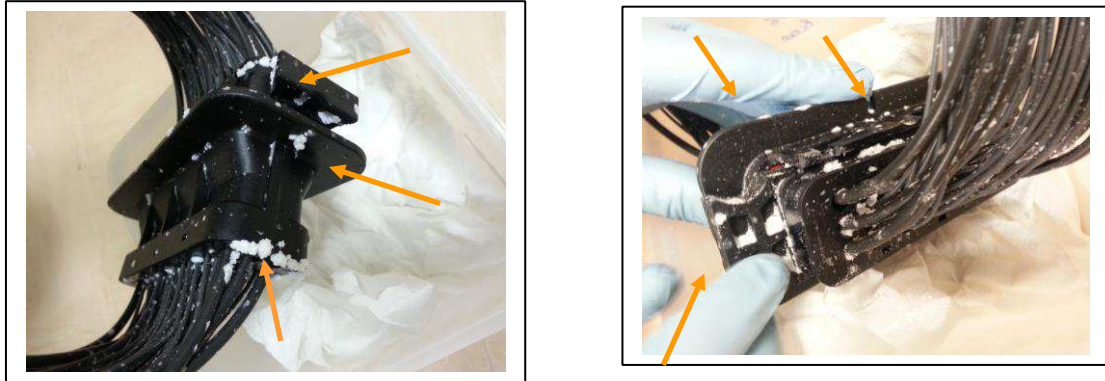
Figure 10: Fluid Resistance test: ADBLUE, formation of Urea crystals on part as water evaporates from ADBLUE solution during 24 Hour air dry cycles.

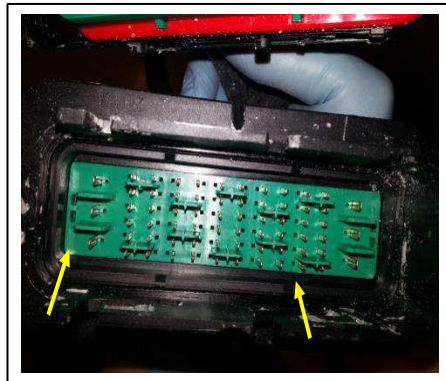
Figure 11: No Urea crystals on mating surface of part

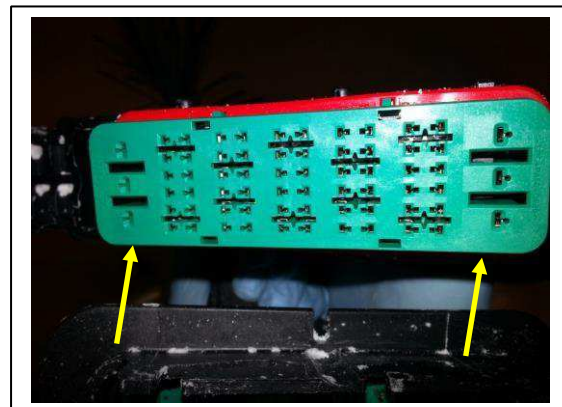
Figure 12: No Urea crystals on mating surface of part

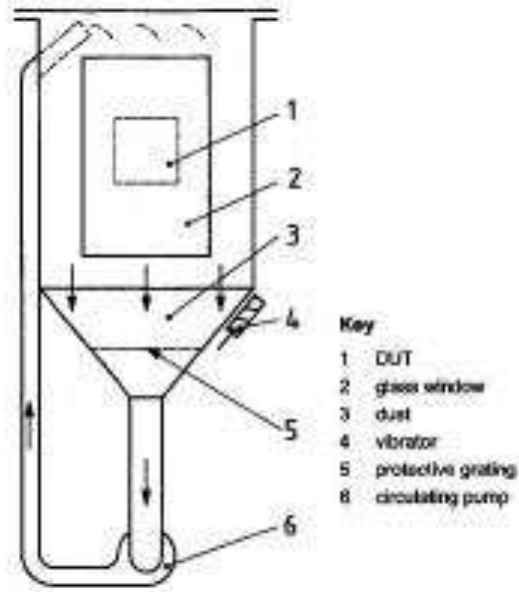
Figure 15: Test set-up for IP6KX (example of a dust chamber with vertical flow of the air/dust mixture)

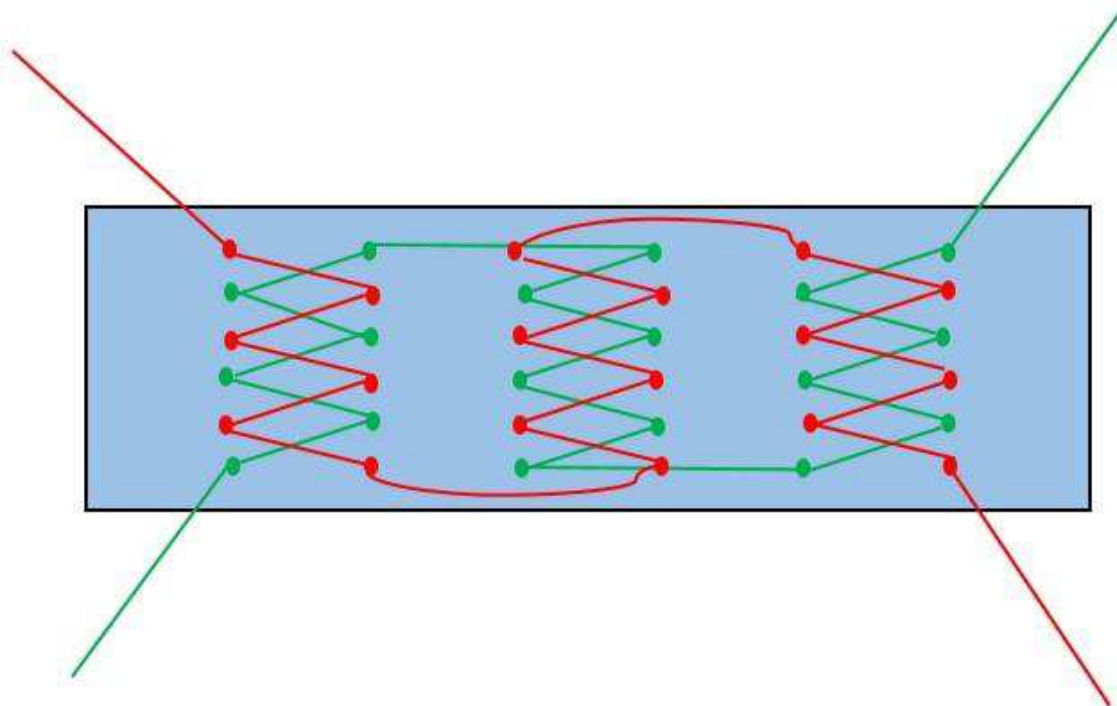
Figure 19: demonstrates the wiring diagram used to bus the connector harness

Harnesses were bussed in this way so that all terminals were wired opposite to its neighboring terminals,
 Note: only 3 pockets are shown in the wiring diagram as the diagram repeats itself across the connector

All connector samples that underwent immersion test were bussed so that all adjacent cables could be tested at once to reduce testing time between individual adjacent terminals (see Figure 26).

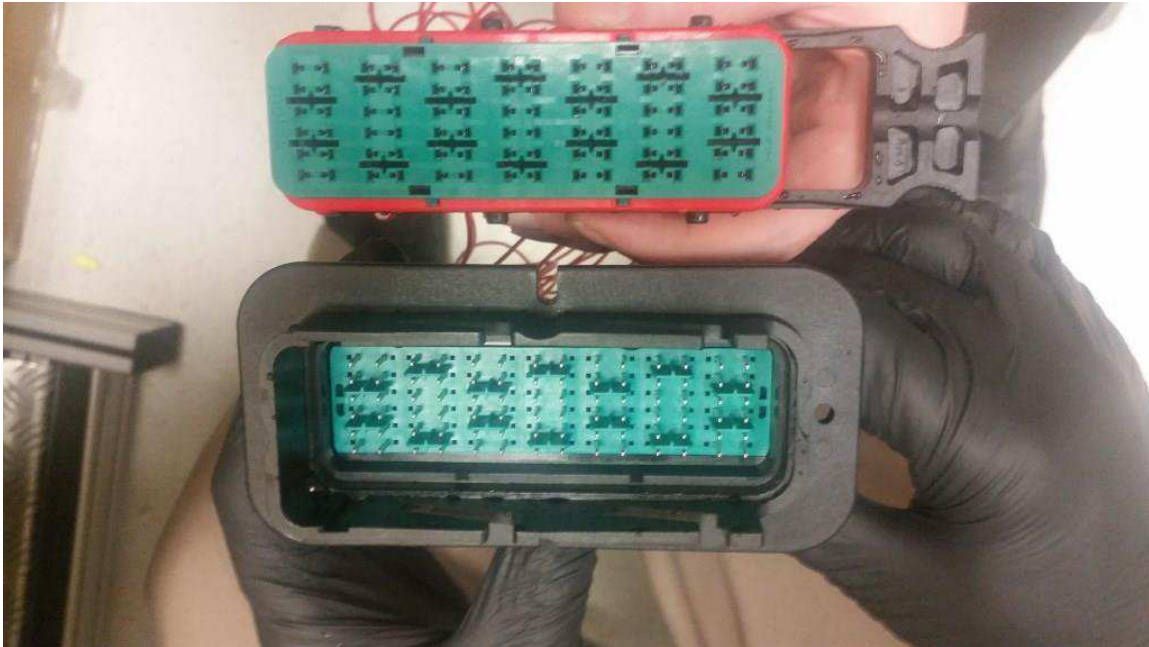
Figure 20: Visual Inspection Post Insulation Resistance/Immersion Test, No ingress of solution
