Testing was performed on the TE Connectivity VITA 66.5, Style A, Fiber-Optic Connector for Use with Multi-Mode MT Ferrules to determine its conformance to the requirements of Product Specification 108-163027, Revision B.

This report covers the optical, mechanical and environmental performance of the VITA 66.5, Style A, Fiber-Optic Connector for Use with Multi-Mode MT Ferrules. Testing was performed at the Fiber Optic Test Laboratory of the Harrisburg Electrical Component Test Laboratory (HECTL) between 26-May-2020 and 18-Aug-2020. The test file numbers for this testing are EA20200192T (for Test Group 1) and EA202000193T (for Test Group 2). This documentation is on file at and available from the HECTL – Fiber Optics Lab.

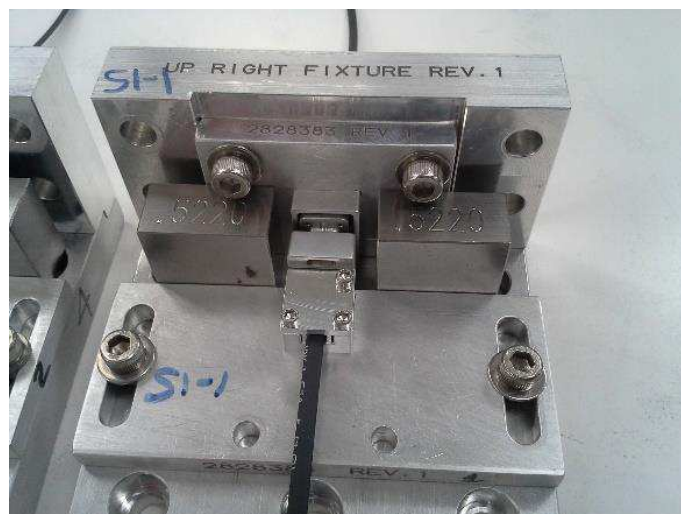
Then, the VITA 66.5, Style A, receptacle (backplane) and plug (plug-in module) connectors were installed in the environmental test fixture shown in Figure 3.2-2. The receptacle connector was mounted to a plate containing an aperture, simulating a backplane. This plate was oriented vertically in the test fixture, as shown in Figure 3.2.2. The plug connector was mounted to fixturing accepting an MT cable assembly, mechanically simulating an assembled transceiver and interposer. This fixturing was mounted to a plate simulating the plug-in module card, which was oriented horizontally in the test fixture.

Figure 3.2-2 VITA 66.5, Style A, Connectors Installed in the Environmental Test Fixture

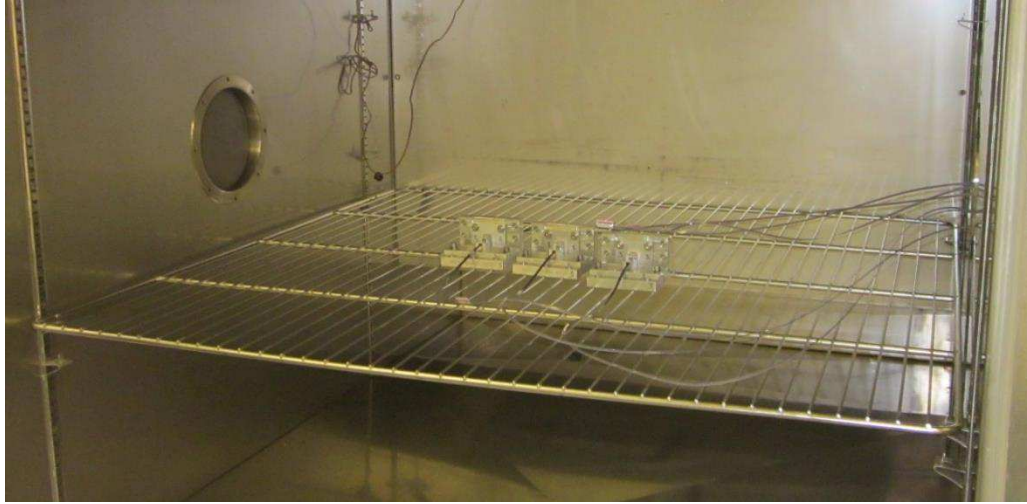
Temperature Cycling was performed per TIA-455-3B, Test Condition C, except with the dwell at the hot extreme performed first. Mated samples were mounted in the environmental test fixtures at the ANSI/VITA 66.0 minimum connector engagement distance. Figure 3.4-1 shows the test fixtures with samples installed, placed within the environmental chamber.

Figure 3.4-1 Connectors Installed in Environmental Test Fixtures, Inside the Chamber

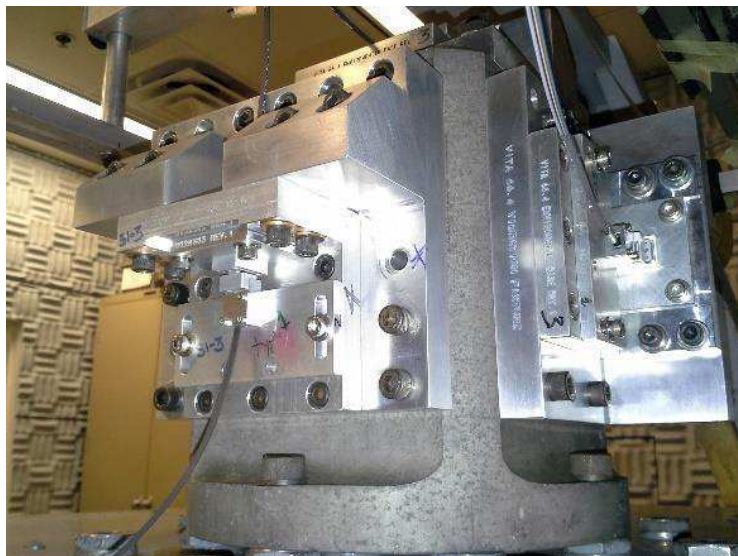
Random Vibration was performed per TIA-455-11D, Test Condition VI, Test Condition Letter D, except with a modified duration of 1 hour per direction. The samples, still mounted in the environmental fixtures at the minimum connector engagement distance, were installed undisturbed into the mechanical test fixtures. These fixtures were then mounted to the vibration table cube, as shown in Figure 3.5-1, and baseline optical measurements recorded. Each mated sample pair was subjected to 11.95 GRMS between 50 and 2000 Hz of Random Vibration for 1 hour in each of three mutually perpendicular directions.

Figure 3.5-1 Connectors Installed in Environmental & Mechanical Test Fixtures, Mounted to the Vibration Table Cube

Sinusoidal Vibration was performed with guidance from TIA-455-11, Test Condition 1. The samples, remaining mounted in the environmental fixtures at the minimum mating engagement distance per ANSI/VITA 66.0, were installed undisturbed into the mechanical test fixtures. The fixtures were then mounted to the vibration table cube, as shown previously in Figure 3.5-1, and baseline optical measurements were recorded.

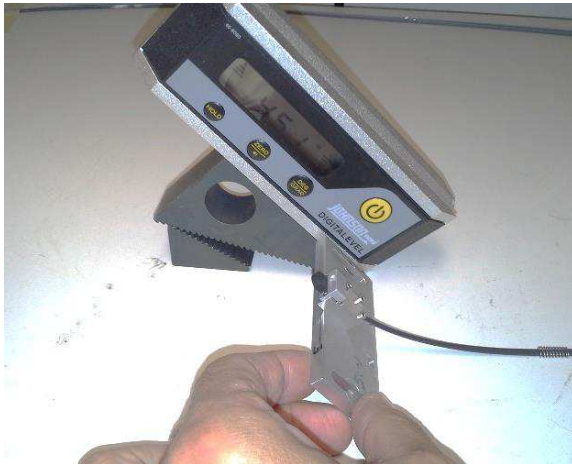
One edge of a plug connector mounting plate was manually raised and aligned with a calibrated digital level supported at a 45° angle as shown in Figure 3.10-1. The plate was then released and allowed to drop back to its original flat position on the bench top. The same edge of the plate was raised and dropped seven more times for a total of eight drops for that plate edge. The plate was then subjected to eight drops from each of the three remaining edges for a grand total of 32 drops per plug connector sample.

Figure 3.10-1 Plug Connector Installed on the Mounting Plate, positioned at 45° for the Bench Handling Shock Test

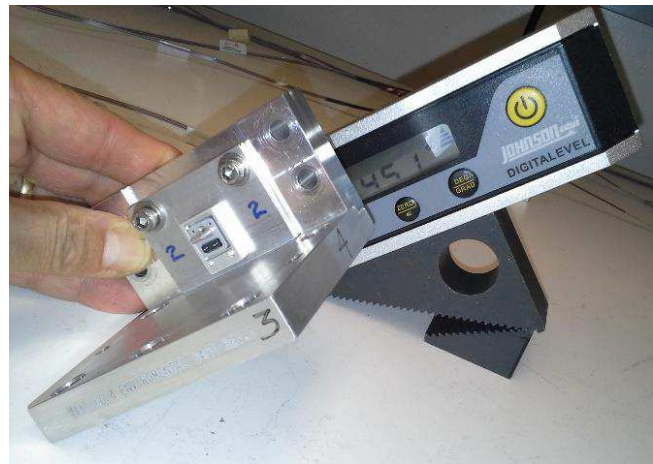
In a like manner, each receptacle connector and environmental fixture was subjected to 32 drops, eight drops for each of the four edges, as shown in Figure 3.10-2. The samples were cleaned, inspected and reconnected at the minimum connector engagement distance. Then, final optical measurements were recorded.

Figure 3.10-2 Receptacle Connector Installed on the Environmental Fixture, positioned at 45° for the Bench Handling Shock Test
