DEUTSCH* DRBM-3X Interface Flange Validation

Testing was performed on DEUTSCH DRBM-3X Interface Flange to determine conformance to mechanical tests and IPX5. Test procedures are given in customer specific specifications.

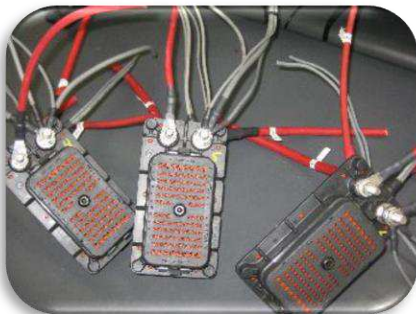
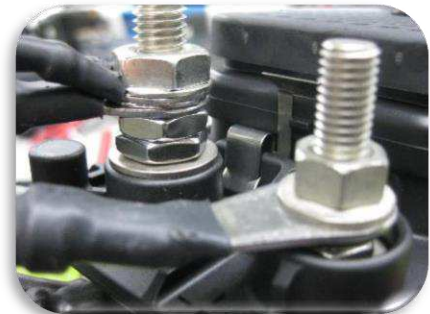
2.4. Torque Relaxation (Group 2)

F. Method: Install customer provided pre-assembled cable and mounting hardware. Torque hardware onto the studs to 10.5 NM. Remove the nut while measuring the torque value. Record values. Perform thermal cycle test. Remove the nut while measuring the torque value. Record values. and inspect for any evidence of cracking, distortion or detrimental damage to the connector.

G. Requirement: Inspect for any evidence of cracking, distortion or detrimental damage to the flange

H. Result: **PASSED.**

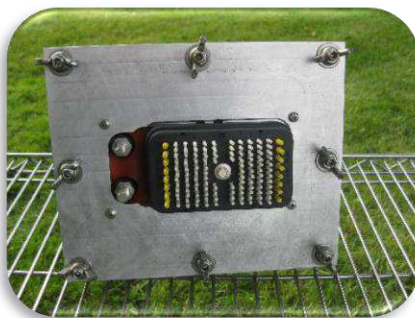
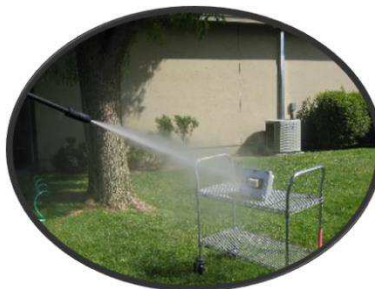
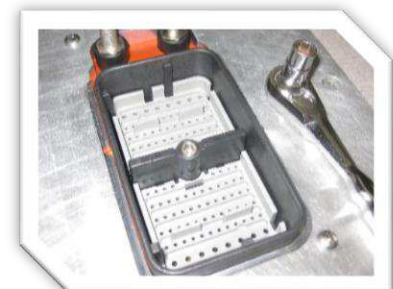
2.5. Protection Against Low Pressure Water Jet (IPX5) (Group 3)

F. Method: Place test sample inside an enclosure. Spray the enclosure using a water jet with 6.3mm nozzle. Water volume: 12.5 lpm; pressure: 30kPa, distance: 3 meters, test duration: ≥ 3 minutes.

a. Test deviation: Used 1800 psi high pressure spray

G. Requirement: No water inside of enclosure

H. Result: **PASSED.**
