This instruction sheet covers information on Next Generation Controller (NGC) 38-Way Female Connectors. See Figure 1.

2. DESCRIPTION (Figure 1)

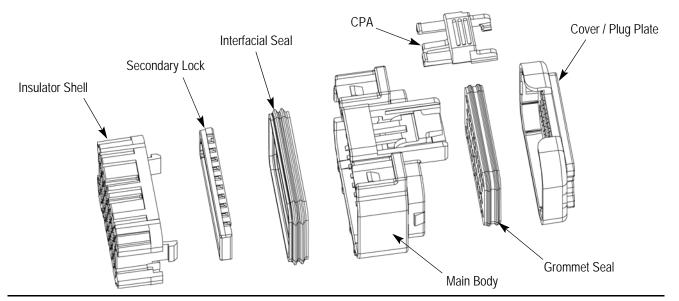
Figure 1

Each 38-way female connector consists of an insulator shell, secondary lock, interfacial seal, main body, grommet seal, cover/plug plate, and a CPA.

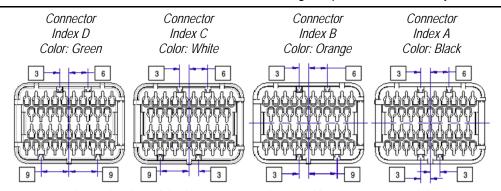
Figure 2

The female connector assemblies are keyed and color coded to match their mating header bay (i.e. either A, B, C, or D) on the NGC module. See Figure 2. The female connector assembly has been designed to be inserted into the proper mating bay with very little effort. An audible "click" will be heard when the female connector assembly's main latch passes over the locking ramp on the header bay.

Looking at header with latches facing toward you, and bay openings toward the top.

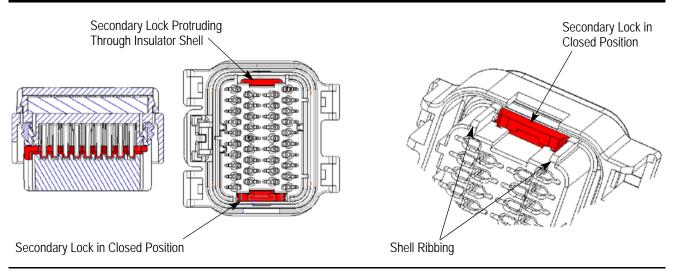
Figure 7

To verify that the secondary lock is in the closed position, look at the bottom (terminal end) of the connector, and confirm that the secondary lock protrudes through both ends of the connector shell. When the secondary lock has been properly closed, the red rectangular tab will be positioned inside the ribs of the shell. See Figure 7.

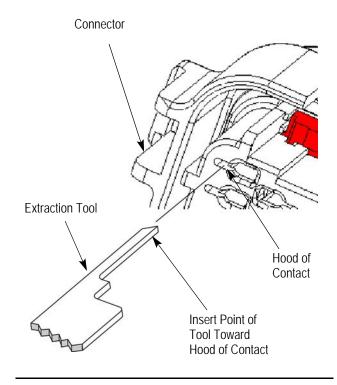
Figure 10

- 2. Use Extraction Tool 8638 from SPX Miller Special Tools to remove the terminals from the connector.
 - a. Insert the tip of the extraction tool in the slot along side of the terminal hood, with the point of the tool toward the terminal hood. See Figure 10.
 - b. Insert the tool until a resistive force from the primary locking finger is felt.
 - c. Pull on the wire of the terminal to be extracted.
 - d. If the terminal will not pull out of the cavity, apply a little more axial force to the extraction tool handle. Tilt the tool toward the terminal side to act as a lever arm to push the primary locking finger away from the terminal.
