GET (Global Electronic Technology) PCM (Powertrain Control Module) Connector, Female (Sealed)

Contact Assembly Instructions

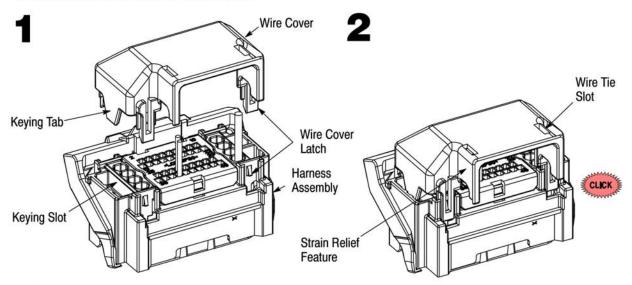
Wire Cover/Strain Relief Installation

Align keying tab with open slot on harness assembly and align wire cover latches.

Press until audible "click" is heard at all four corners and wire cover is secure. Use wire tie through slots in cover, or approved tape around strain relief feature, to secure wires to wire cover.

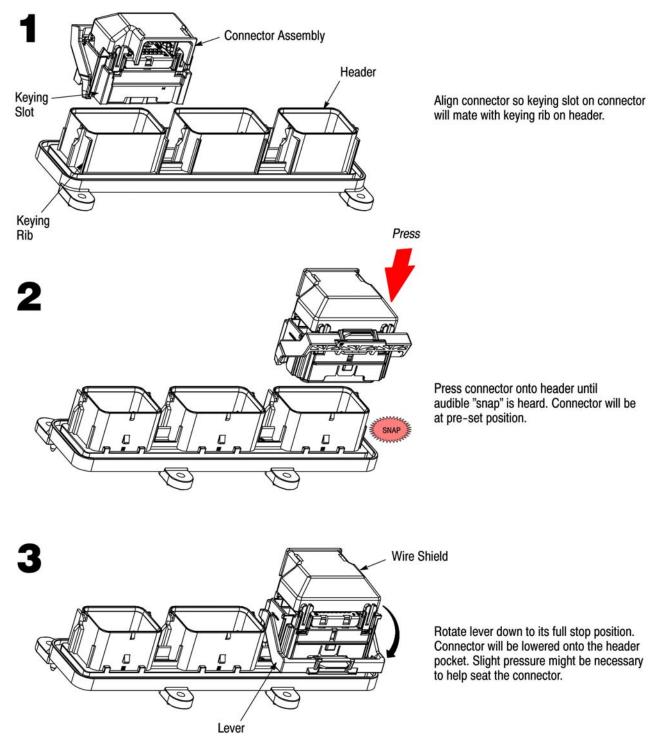
Mating Connector to Header

NOTE: Reverse Steps 2 and 3 to remove the connector from the header. **CAUTION:** Do NOT pull on wires when removing the connector as damage may occur.
