RF Multi-Coaxial Connector and Cable Assembly

This report covers the electrical, mechanical, and environmental performance of the RF Multi-Coaxial Solution Connector. Testing was performed at the Engineering Assurance Product Test Laboratory between September 5, 2022 and November 5, 2022. The test file numbers for the testing are TP-22-01229 and TP-22-01982. This documentation is on file at and available from the Engineering Assurance Product Test Laboratory.

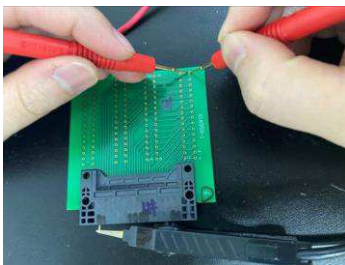
Figure 1 – Typical LLCR Setup, Center Contact

Low level contact resistance measurements at low level current were made using a four terminal measuring technique. The test current was maintained at 30 milliamperes maximum with a 1 volt maximum open circuit voltage. Testing was performed in accordance with Test Specification EIA-364-06C. See Figures 1 and 2 for typical setups.

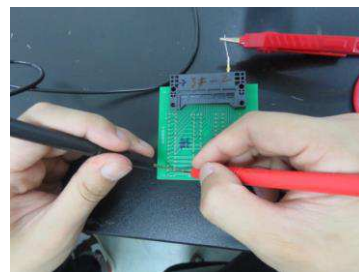
Figure 2 – Typical LLCR Setup, Outer Contact

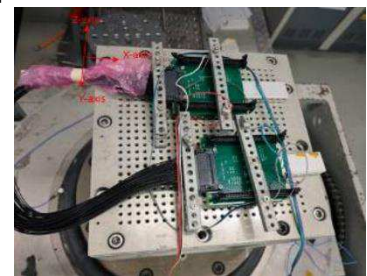
Figure - 3

The test specimens were subjected to a high frequency vibration test as stated in accordance with specification EIA-364-28F. See Figure 3 below for vibration setup photographs

The parameters of this test condition are a simple harmonic motion having an amplitude of either 0.66 mm double amplitude (maximum total excursion) or 20 gravity unit (g's peak) whichever is less.

The vibration frequency was varied logarithmically between the approximate limits of 10 to 55 Hertz (Hz). The entire frequency range of 10 to 55 Hz and return to 10 Hz was traversed in approximately 10 minutes. This cycle was performed 10 times in all three mutually perpendicular axes (total of 30 times), so that the motion was applied for a total period of approximately 2 hours.

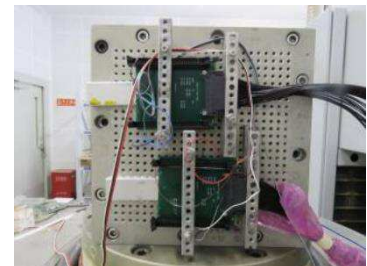
Figure - 4

The test specimens were subjected to a mechanical shock test as stated in TE Connectivity Specification 108-160468, in accordance with specification EIA-364-27C. See Figures 4 below for shock setup photographs

The parameters of this test condition are a half-sine waveform with an acceleration amplitude of 10 gravity units (g's peak) and a duration of 11 milliseconds. Three shocks in each direction were applied along the three mutually perpendicular axes of the test specimens, for a total of eighteen shocks.

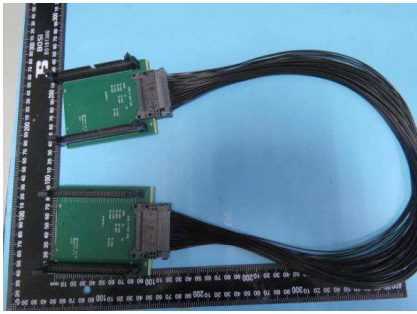
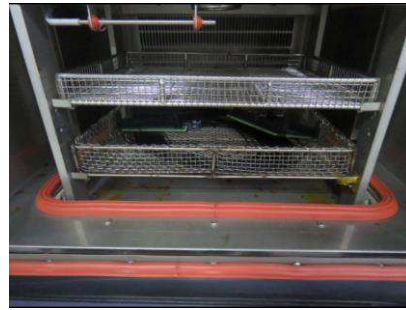
1.3 Thermal Shock test picture:

No evidence of physical damage was visible as a result of thermal shock testing.

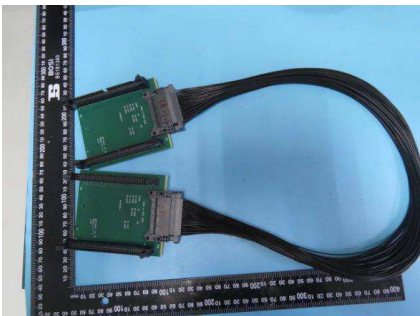
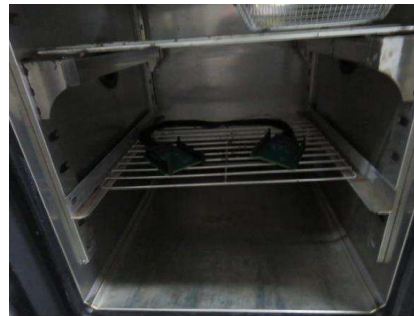
1.4 Humidity and Temperature Cycling test picture:

No evidence of physical damage was visible as a result of humidity-temperature cycling

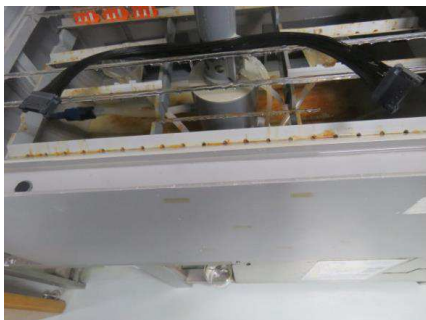
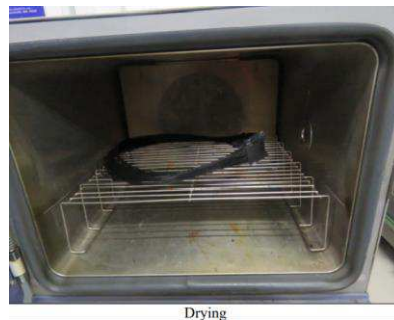
1.5 Salt Spray test picture:

No corrosion was found after test.
