**PLUGGABLE BUS BAR IN-LINE MOUNTING 300A CONNECTOR**

Testing was performed on Pluggable bus bar in-line mounting 300A connector to determine its conformance to the requirements of product specification 108-128012.

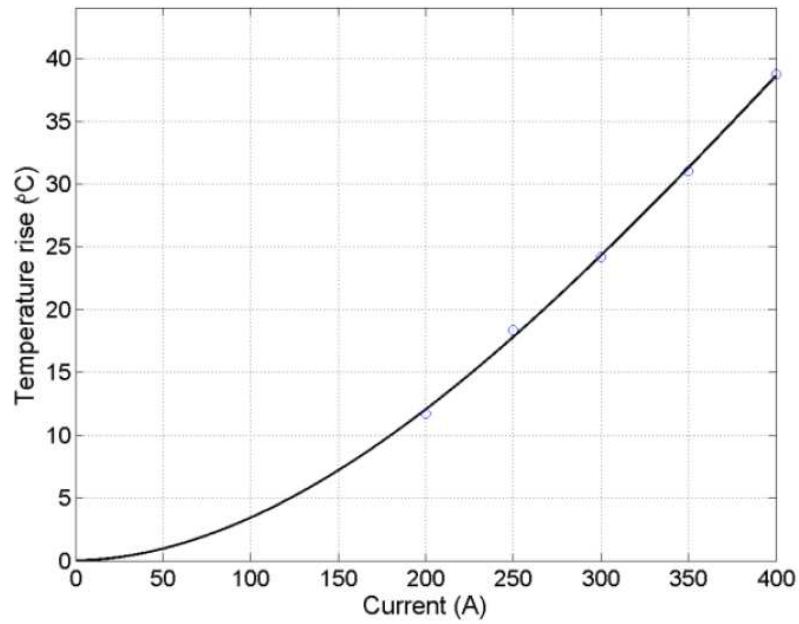
Graphs 1 Temperature rise vs current.

All assemblies had a temperature rise of less than 30°C above ambient when a specified current of 300 amperes current was applied. Detailed T-rise graphs in Appendix 1 (The graphs have been curve fitted from the actual data).

Specimens were subjected to temperature rise vs. current test in accordance with EIA-364-70, Method II. Assembly temperature was measured, while energized at the specified current. Thermocouples were attached to the connectors to measure their temperatures. This temperature was when subtracted from the ambient temperature to find the temperature rise. When three readings at five minute intervals were within 1 °C, the reading were recorded.
