# WILDLIFE INDUCED OUTAGES AND PROTECTION OF OVERHEAD LINES AND SUBSTATIONS

Don Barrett, Wildlife and Asset protection Product Manager, TE Connectivity  
[assetprotection@te.com](mailto:assetprotection@te.com)

First published at the INMR CONGRESS 2015

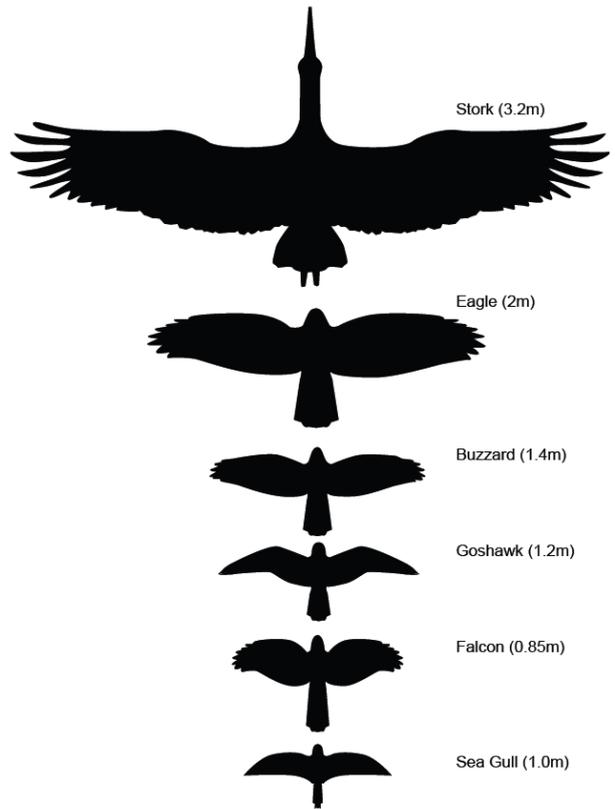
Figure 1. Damage to conductor known as “stranding”. Figure 2. Dead bird fallen away from contact area.

Bridging is where a bird or animal makes contact between phases or between phase and ground creating a short circuit. The illustration below makes it clear how easily large birds can cause problems across all distribution voltages in substations and on overhead lines. Phase bridging usually results in the bird or animal being electrocuted and depending on how the dead bird or animal falls will determine whether the auto-reclosing system operates successfully. Often the bird or animal will fall away allowing the auto-recloser to re-energize the circuit as intended. Although this may not normally require investigation by emergency crews it usually leaves un-noticed damage. (Figure 1 shows typical “tell-tale” sign of wildlife induced damage)

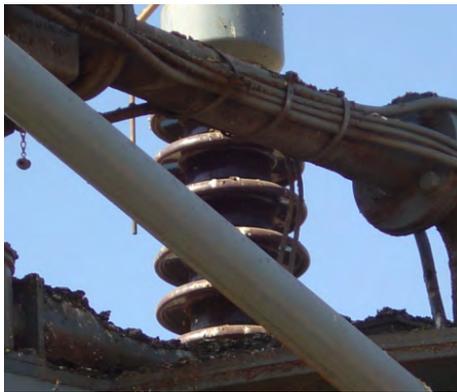
Figure 3. Guano build-up on suspension insulator and on substation equipment.

Pollution flashover takes place on a bushing or insulator when bird guano builds up over a period of weeks or months during dry conditions when there is little or no rain to wash the porcelain or glass. Birds often favor certain places to perch and this is often at the extremity of a lattice tower arm directly above an insulator string. Over time the build-up of guano can be considerable (see Figure 3), but while conditions are hot and dry the relatively small individual amounts of liquid guano quickly dry and the surface resistance level is not greatly altered.

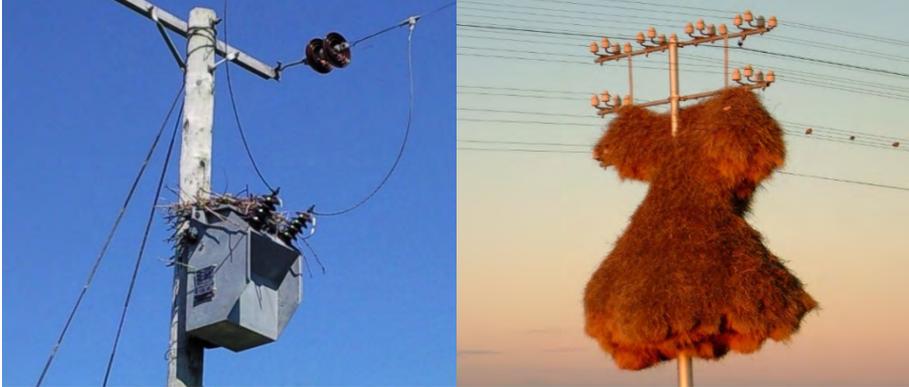
Figure 4. Pole top transformer nest site and huge nest structure in South Africa.

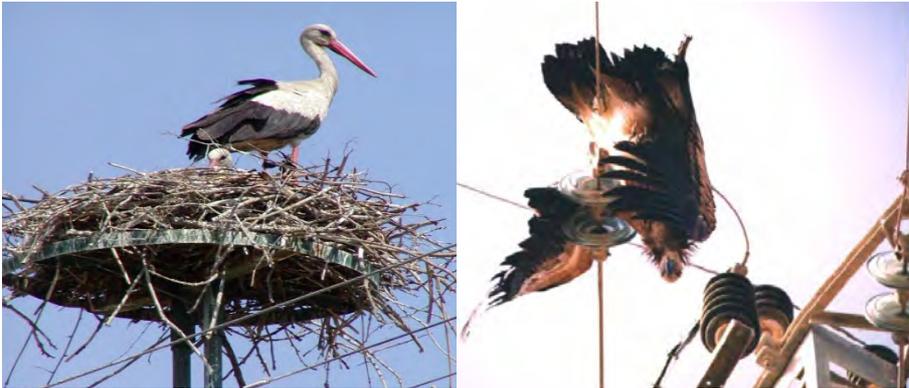
Figure 5. Migratory stork nest in Greece and griffon vulture fatally bridging in Israel.

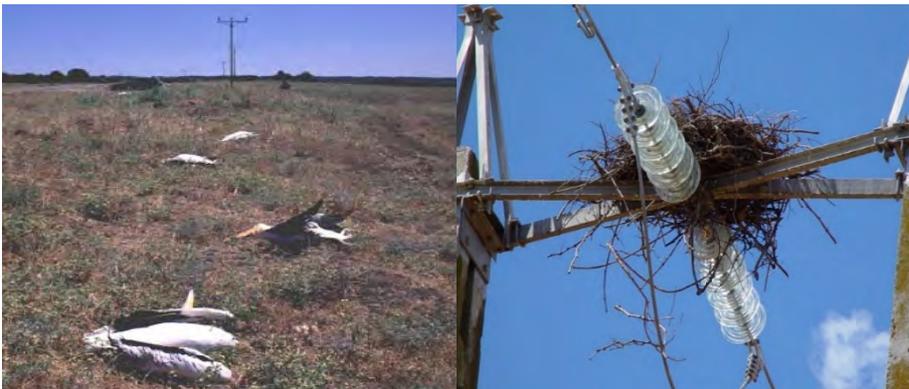
Figure 6. Pelicans dead from clashing conductors, Israel and nest likely to cause flashover, Spain.

Migratory issues concern birds almost entirely. Birds passing through an area to a final destination often stop to feed and rest and in these short periods of time can cause havoc locally by overcrowding mast tops where there is limited perching space available and either bridge phase to ground or between phases. Other incidents include flying into overhead lines near feeding sites, usually at distribution voltages where conductor clearances are such that large birds flying into them can bring two conductors together resulting in flashover (see figure 6)

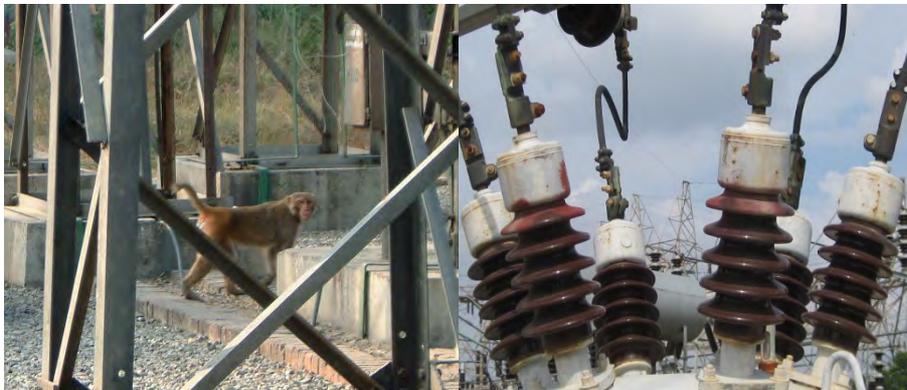
Figure 7. Monkeys in Indian substation and evidence of inter-phase bridging, Greece

It would be possible to show examples of a huge number of bird and animal related issues from different countries, different equipment and different species, but this paper will only show a snapshot of what happens and then concentrate on the best solutions that are proven to reduce these instances where they are employed. Figures 7 & 8 show some typical substation related issues.

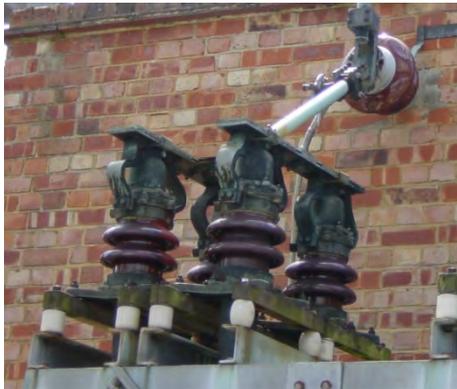
Figure 8. Phase to ground bridging in the U.K. and in Germany

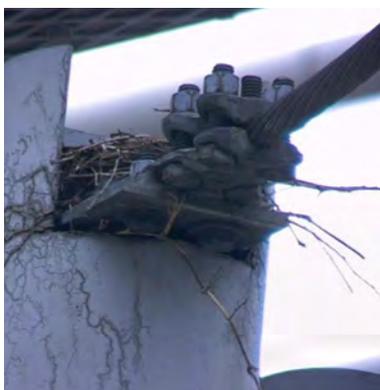
Failure by tracking

The photos below illustrate what can happen in a very short time when the minimum levels of material performance are not met.

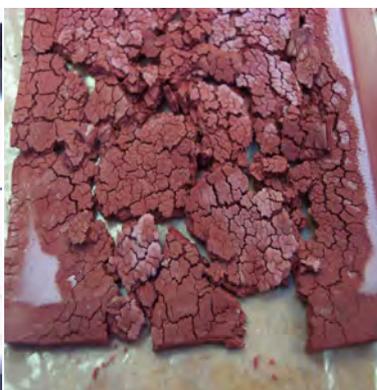
Failure from U.V.

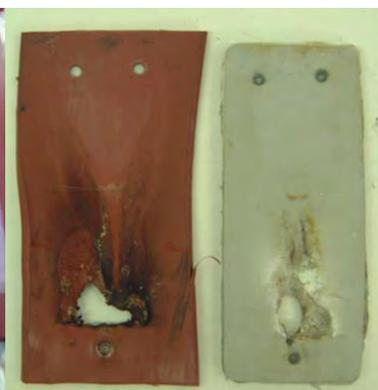
Failure by erosion

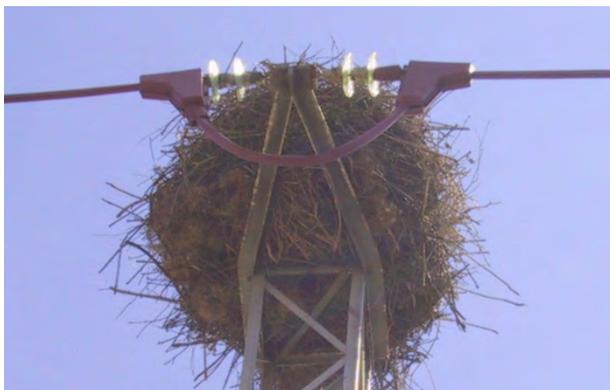
#### Example 1: Migratory birds

A white stork has a 2m+ wing span and thousands migrate from Africa to nest in Spain, central and South-East Europe every year. Its nest is so big, up to 400kg (Reference 10) and 2m in diameter, it would cause flashover at some point either from accidental bridging between nest debris and conductor when conditions are wet or from birds bringing pieces of conductive material e.g. wire to the nest or from the young birds that stray around the nest site prior to fledging and contact a conductor. By insulating the bare metal fittings with a wraparound cover and the conductor with wraparound sleeving approximately 1.5m away from the nest in both directions the bird and system have long-term security.

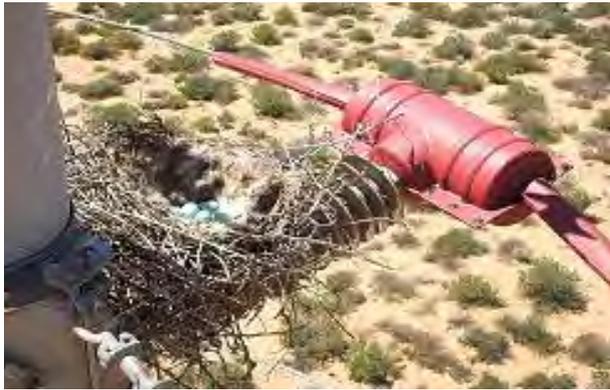
**Example 2: Common occurrence, a crow's nest**

This crow's nest in South Africa on a 66 kV line between insulator and pole is precariously positioned. The wings of the bird during landing or take off from the nest is likely to cause accidental bridging at any time. Without the combination of conductor sleeve and wrap around connection cover this bird/nest combination would at some point cause flashover. The nest while dry conditions last may not cause a problem, however, once conditions become wet (rain, mist, fog etc.) it is likely to short out enough of the insulator to cause flashover. Even if dry conditions remain once the young birds are big enough to move about it is almost inevitable they will cause a flashover.

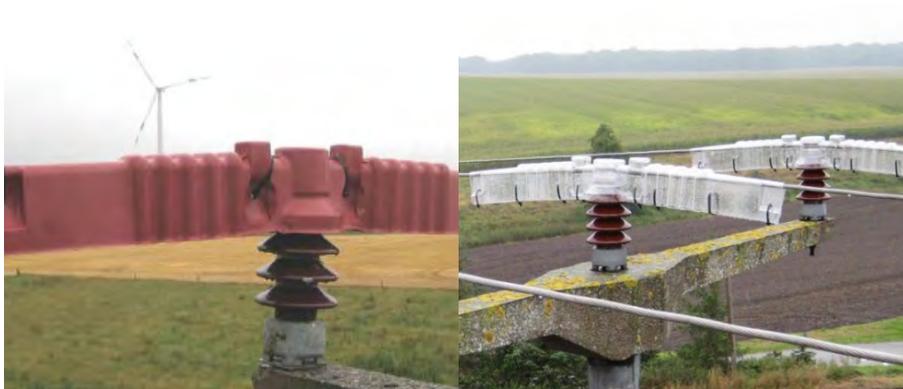
**Example 3: Bird protection in Germany**

Utilities in Germany are required by legislation to implement counter measures to prevent electrocution of birds and protect both migratory and domestic species.

The solution is to use protection that prevents electrocution of birds (Reference 12) on the 10/20 kV distribution mast tops. This is achieved by preventing accidental contact between the bird and live conductors, providing insulation covers with an overall length of approximately 1.4m. There are many designs that can be attached by cable ties (left photo) or with insulated poles (hot-sticks) with the system energized. It is also possible to use transparent materials (right photo) that allows aerial inspection of the overhead lines in terrain difficult to access. This may become more widely used as some utilities introduce "drones" for aerial surveillance.

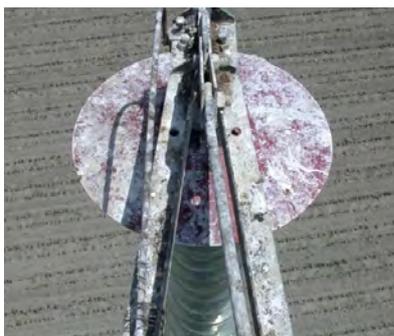
**Example 4: Bird guano**

This insulator string demonstrates how the entire length of string can become heavily polluted with bird guano if not protected, the second photo shows that by shielding an insulator string it is possible to keep the surfaces clean enough to never suffer pollution flashover. It is critical the material and design of the shield give many years of maintenance free service, ideally made of high performance U.V. stable polymer and robustly secured at the top of the string. After seasonal rain storms the guano will wash away and fall harmlessly away from the string below. In countries of extreme dry conditions where it might only rain heavily once in several years it is even more important to use a material of high U.V. stability and resistance to uric acid (guano).

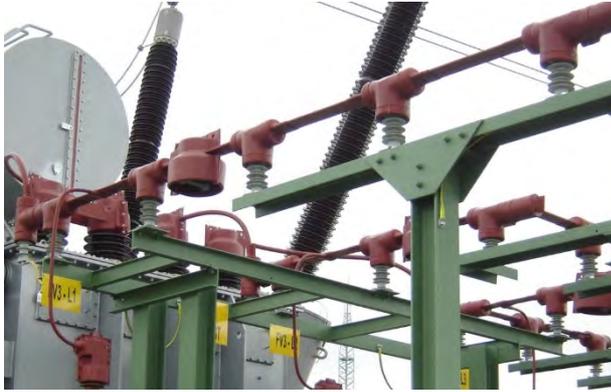
**Example 5: Urban substation protection**

This substation in Croatia shows all bare live metalwork insulated, busbars with heat shrink tubing, connection points with cold applied wrap around covers that can be removed for maintenance or inspection and re-used. The issue was phase to ground clearances on medium voltage side of transformer and bus network where typical 40cm air gaps were being bridged by cats and birds (crows & pigeons).

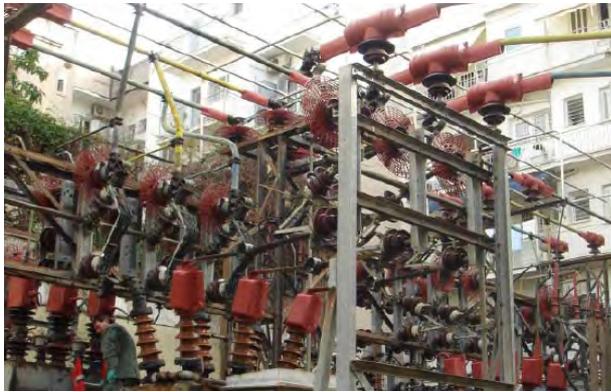
**Example 6: City center substation**

An ageing medium voltage substation in central Athens with huge numbers of cats and pigeons. Many phase to ground clearances well below the nominal 40cm distances and previously suffered multiple flashovers. Solution was to cover the vulnerable bare metalwork with a range of high performance polymeric covers, wraparound sleeving and circular barriers that prevent cats climbing over the insulator and being able to touch Medium Voltage and ground at the same time.

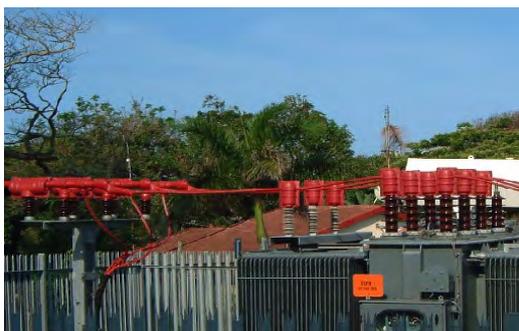
**Example 7: African rural substation**

This new medium voltage substation in South Africa was built on an area of cleared scrub and trees inhabited by a troop of large monkeys. In the first year of operation it suffered 12 flashovers caused by monkeys that considered this their territory. The solution was to insulate all live bare metalwork across the site with a combination of heat shrink tubes and several wraparound covers. Fully understanding the situation was critical to the success on this site because the phase clearances in some parts were approximately 1m which normally would not require insulating but as the main problem was large monkeys they can easily bridge a 1m gap.

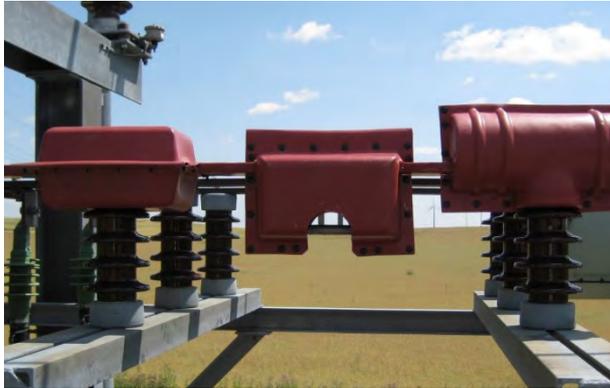
#### **Example 8: 20 kV substation in rural Germany**

This 20 kV substation in rural Germany is insulated against climbing animals such as martens and cats using wraparound covers that are field cut on site to accommodate any unusual geometry including the center cover where a cut-out has been added to allow access for an earth clamp in a relatively safe position. Covers that need field cutting benefit from being produced from a polymeric cross linked material because they will never propagate splits if they are roughly cut.
