WILDLIFE INDUCED OUTAGES AND PROTECTION OF OVERHEAD LINES AND SUBSTATIONS

Don Barrett, Wildlife and Asset Protection Product Manager, TE Connectivity

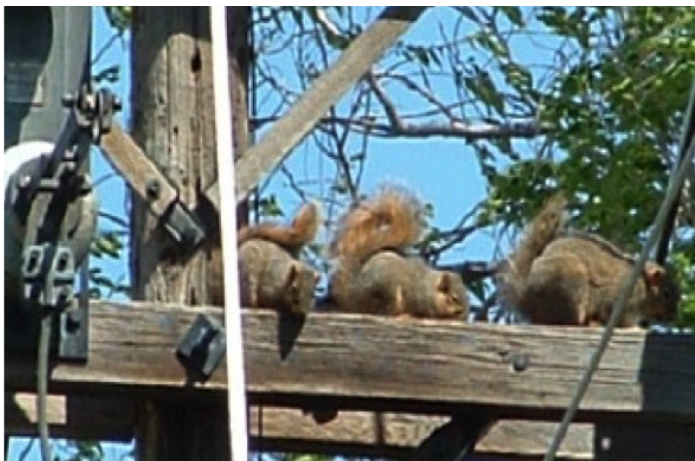
Most bridging problems occur on Medium Voltage systems (typically <36 kV) designed where bare conductors, bushings, busbar systems and associated equipment have “air-spaced” clearances that under normal conditions operate without issue. Clearances are typically up to 40cm (Reference 1) in substations and approximately 1m for overhead lines to allow for swinging conductors. These clearances unfortunately allow a wide range of birds and animals to cause huge problems in substations and birds predominantly on overhead lines. It should be noted that although overhead line conductors are typically 1m apart, the most common failure mode is between the cross arm (usually grounded) and conductor, which is typically 30 to 40cm.

Medium and large size birds stand on the cross arm and bridging usually occurs during landing or takeoff when the bird has open wings. In more unusual cases other wildlife such as bears, possums or snakes can climb the poles and cause similar problems. These are very location specific.

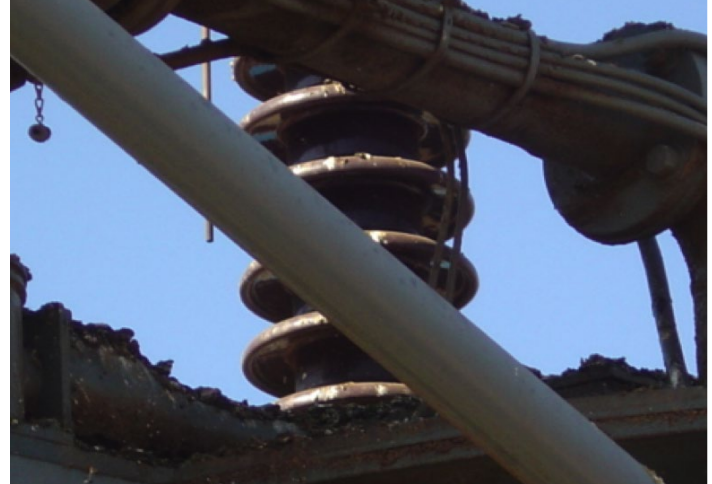
Figure 3. Guano build-up on suspension insulator and on substation equipment.

Pollution flashover takes place on a bushing or insulator when bird guano builds up over a period of weeks or months during dry conditions when there is little or no rain to wash the porcelain or glass. Birds often favor certain places to perch and this is often at the extremity of a lattice tower arm directly above an insulator string. Over time the build-up of guano can be considerable (see Figure 3), but while conditions are hot and dry the relatively small individual amounts of liquid guano quickly dry and the surface resistance level is not greatly altered.

Flashover can occur after this period of dry weather when mist, fog or rain first returns which has the effect of changing the dried guano into a semi-liquid state and greatly reduces the surface resistance of the porcelain or glass. If the build-up of guano is enough once moisture is present to change the conductivity of the whole insulator string, flashover can result. It should also be noted that another bird related failure mechanism that of “Guano Streamers” can cause flashover when a bird perched above an energized conductor emits a liquid streamer up to 2m long (Reference 2) which can effectively short out the otherwise safe air gap.

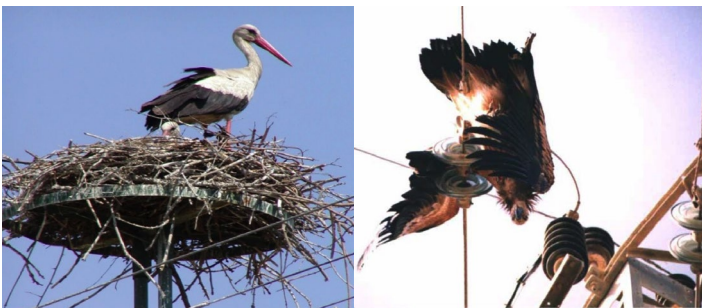
Figure 5. Migratory stork nest in Greece and griffon vulture fatally bridging in Israel.

a final destination often stop to feed and rest and in these short periods of time can cause havoc locally by overcrowding mast tops where there is limited perching space available and either bridge phase to ground or between phases. Other incidents include flying into overhead lines near feeding sites, usually at distribution voltages where conductor clearances are such that large birds flying into them can bring two conductors together resulting in flashover. (see figure 6)

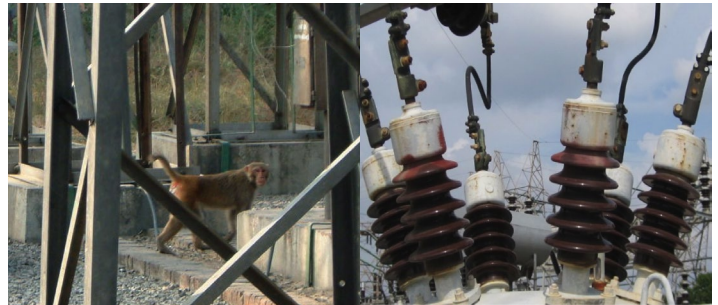
Figure 7. Monkeys in Indian substation and evidence of inter-phase bridging, Greece

Problems in substations are almost exclusively of a bridging nature where birds or animals bridge phases or phase to ground. Issues are generally not migratory related but can be seasonal, e.g. during cold weather when cats and other similar size creatures are attracted to the warmth that being close to a transformer offers. It is considered seasonal when for example small birds build nests and a range of predators, depending on the location, such as cats, martens, snakes, birds and other species are looking for a food source to feed their own young.

animal related issues from different countries, different equipment and different species, but this paper will only show a snapshot of what happens and then concentrate on the best solutions that are proven to reduce these instances where they are employed. Figures 7 & 8 show some typical substation related issues.

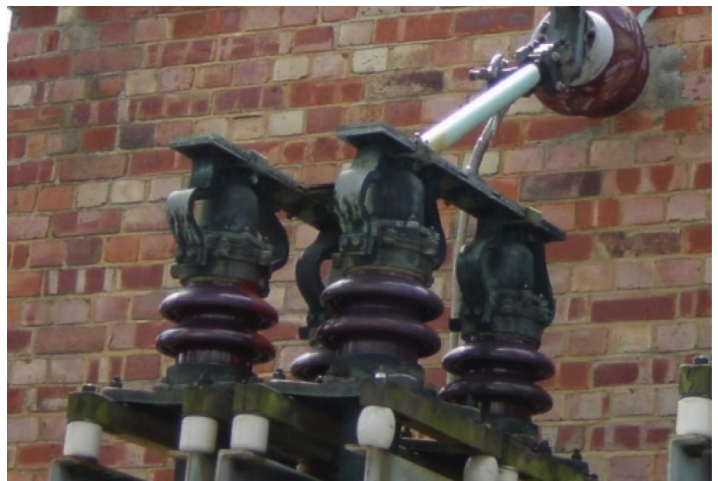
Figure 8. Phase to ground bridging in the U.K. and in Germany

In medium voltage substations as a rule of thumb, anything up to 40cm between phases or phase and ground is considered vulnerable to bridging by wildlife. This can of course be a far greater distance, perhaps up to 1m if the substation in question is plagued by wildlife that can bridge much farther such as snakes, monkeys and large birds of prey.

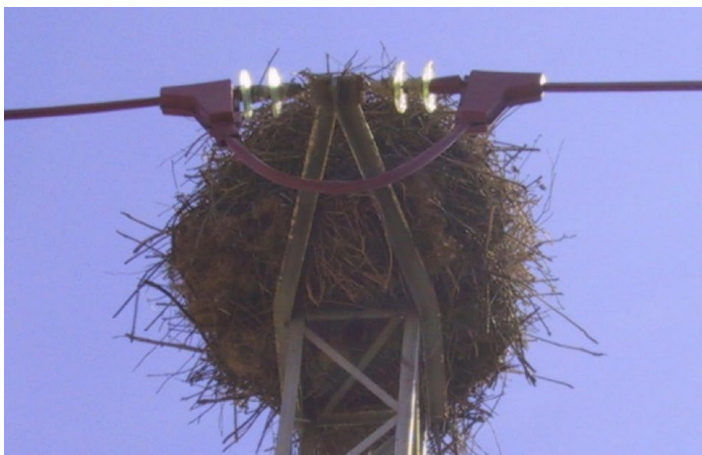
Example 1: Migratory birds

A white stork has a 2m+ wing span and thousands migrate from Africa to nest in Spain, central and South-East Europe every year. Its nest is so big, up to 400kg (Reference 10) and 2m in diameter, it would cause flashover at some point either from accidental bridging between nest debris and conductor when conditions are wet or from birds bringing pieces of conductive material e.g. wire to the nest or from the young birds that stray around the nest site prior to fledging and contact a conductor. By insulating the bare metal fittings with a wraparound cover and the conductor with wraparound sleeving approximately 1.5m away from the nest in both directions the bird and system have long-term security.

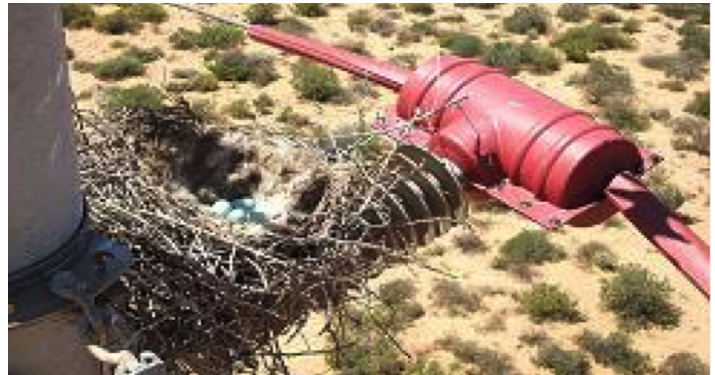
Example 2: Common occurrence, a crow's nest

This crow's nest in South Africa on a 66 kV line between insulator and pole is precariously positioned. The wings of the bird during landing or take off from the nest is likely to cause accidental bridging at any time. Without the combination of conductor sleeve and wrap around connection cover this bird/nest combination would at some point cause flashover. The nest while dry conditions last may not cause a problem, however, once conditions become wet (rain, mist, fog etc.) it is likely to short out enough of the insulator to cause flashover. Even if dry conditions remain once the young birds are big enough to move about it is almost inevitable they will cause a flashover.

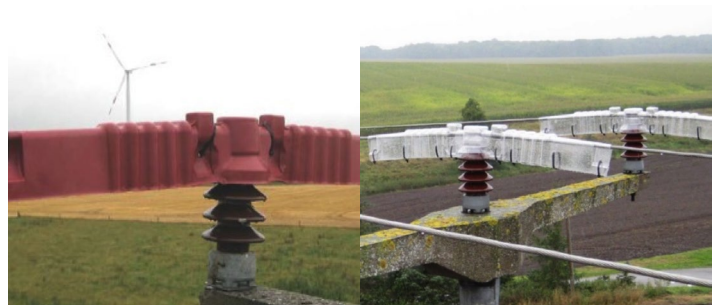
Example 3: Bird protection in Germany

Utilities in Germany are required by legislation to implement counter measures to prevent electrocution of birds and protect both migratory and domestic species. The solution is to use protection that prevents electrocution of birds (Reference 12) on the 10/20 kV distribution mast tops. This is achieved by preventing accidental contact between the bird and live conductors, providing insulation covers with an overall length of approximately 1.4m. There are many designs that can be attached by cable ties (left photo) or with insulated poles (hot-sticks) with the system energized. It is also possible to use transparent materials (right photo) that allows aerial inspection of the overhead lines in terrain difficult to access. This may become more widely used as some utilities introduce "drones" for aerial surveillance.

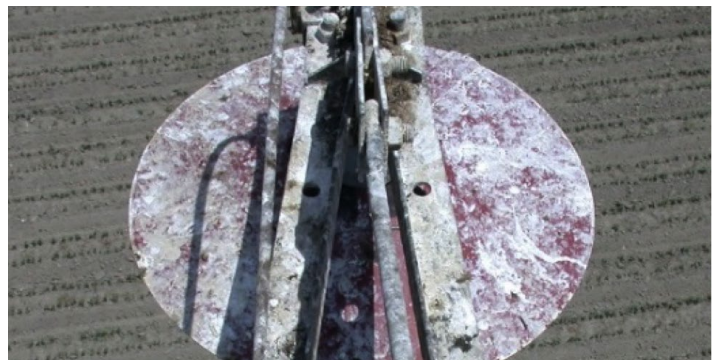
Example 4: Bird guano

This insulator string demonstrates how the entire length of string can become heavily polluted with bird guano if not protected, the second photo shows that by shielding an insulator string it is possible to keep the surfaces clean enough to never suffer pollution flashover. It is critical the material and design of the shield give many years of maintenance free service, ideally made of high performance U.V. stable polymer and robustly secured at the top of the string. After seasonal rain storms the guano will wash away and fall harmlessly away from the string below. In countries of extreme dry conditions where it might only rain heavily once in several years it is even more important to use a material of high U.V. stability and resistance to uric acid (guano).

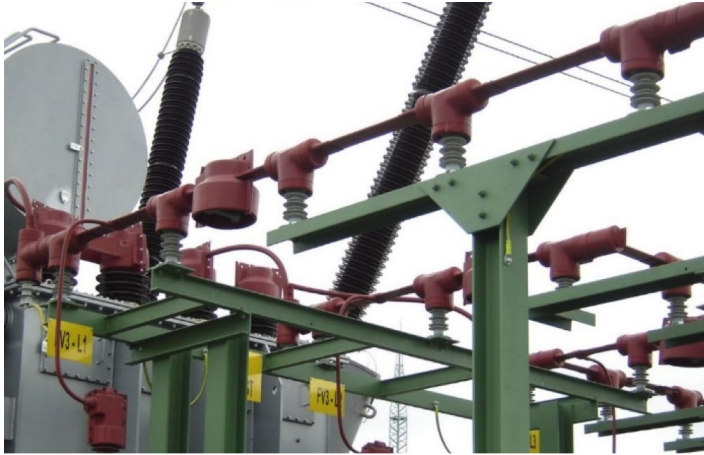
Example 5: Urban substation protection

This substation in Croatia shows all bare live metalwork insulated, busbars with heat shrink tubing, connection points with cold applied wrap around covers that can be removed for maintenance or inspection and re-used. The issue was phase to ground clearances on medium voltage side of transformer and bus network where typical 40cm air gaps were being bridged by cats and birds (crows & pigeons).

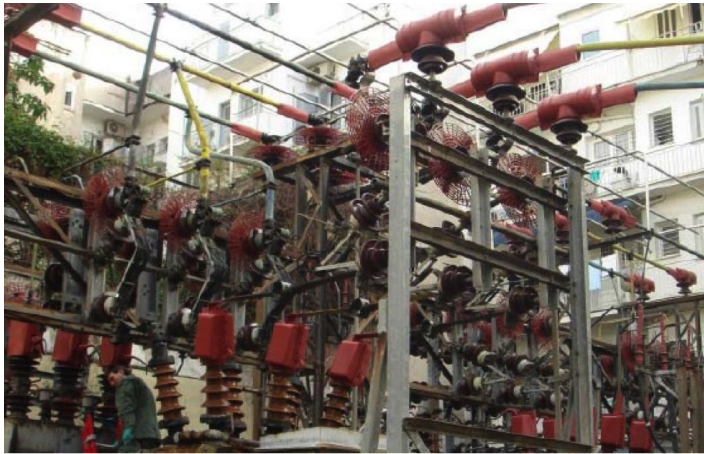
Example 6: City center substation

An aging medium voltage substation in central Athens with huge numbers of cats and pigeons. Many phase to ground clearances well below the nominal 40cm distances and previously suffered multiple flashovers. Solution was to cover the vulnerable bare metalwork with a range of high performance polymeric covers, wraparound sleeving and circular barriers that prevent cats climbing over the insulator and being able to touch Medium Voltage and ground at the same time.

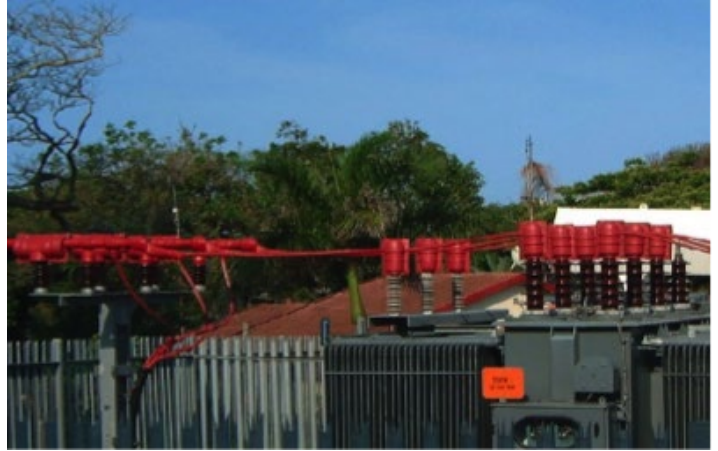
Example 7: African rural substation

This new medium voltage substation in South Africa was built on an area of cleared scrub and trees inhabited by a troop of large monkeys. In the first year of operation it suffered 12 flashovers caused by monkeys that considered this their territory. The solution was to insulate all live bare metalwork across the site with a combination of heat shrink tubes and several wraparound covers. Fully understanding the situation was critical to the success on this site because the phase clearances in some parts were approximately 1m which normally would not require insulating but as the main problem was large monkeys they can easily bridge a 1m gap.
